Tropicana Field

Hurricane Milton Damage Assessment

November 11, 2024

Tropicana Field Roof
Structure Condition Assessment

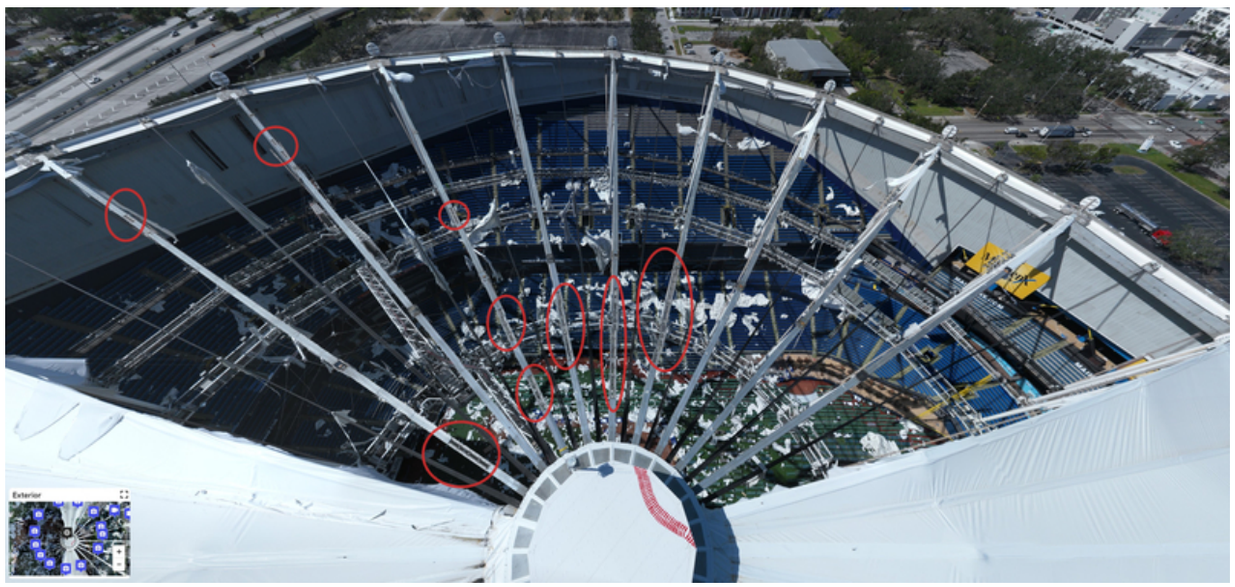
Pin	Issue ID	Description	Location Detail	Status	Company	Type	Date Created	Due Date
1	000082	Sheet metal cover plate missing for ridge cable clamping		Open	<not set>	Issue - Fabric	25 Oct 2024

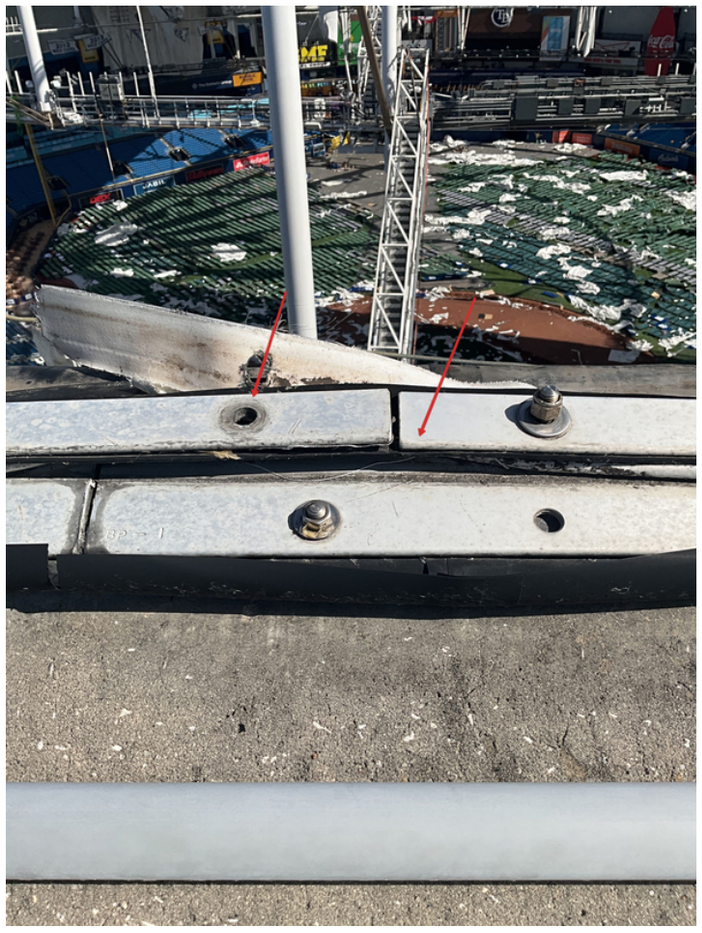
1	000048	Ring beam to fabric clamp failure.		Open	<not set>	Issue - Fabric	22 Oct 2024

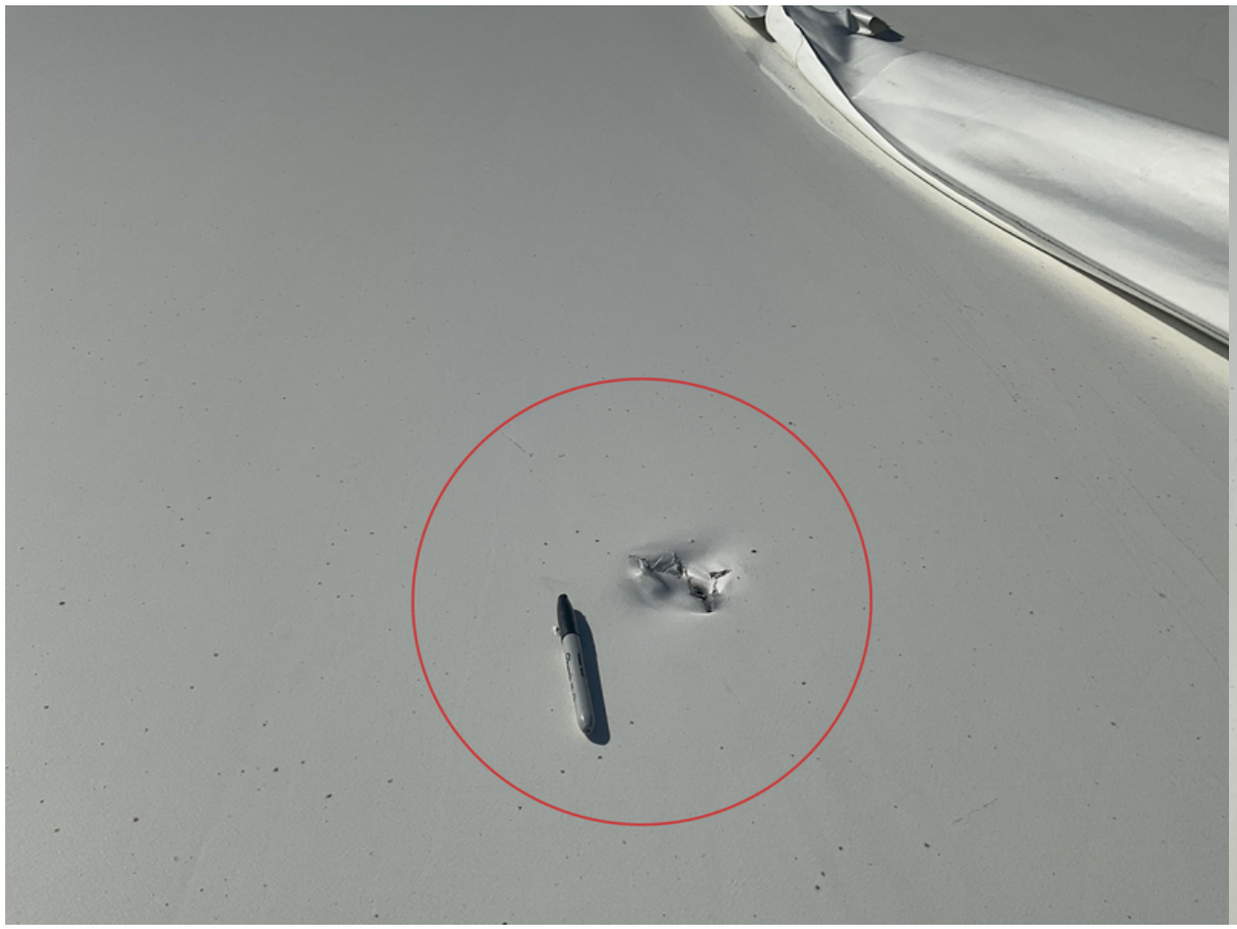
Pin	Issue ID	Description	Location Detail	Status	Company	Type	Date Created	Due Date
2	000036	Fabric tear in remaining panel. Tear should be patched to prevent propagation. This tear was likely caused by the ponding cables below.		Open	<not set>	Issue - Fabric	22 Oct 2024

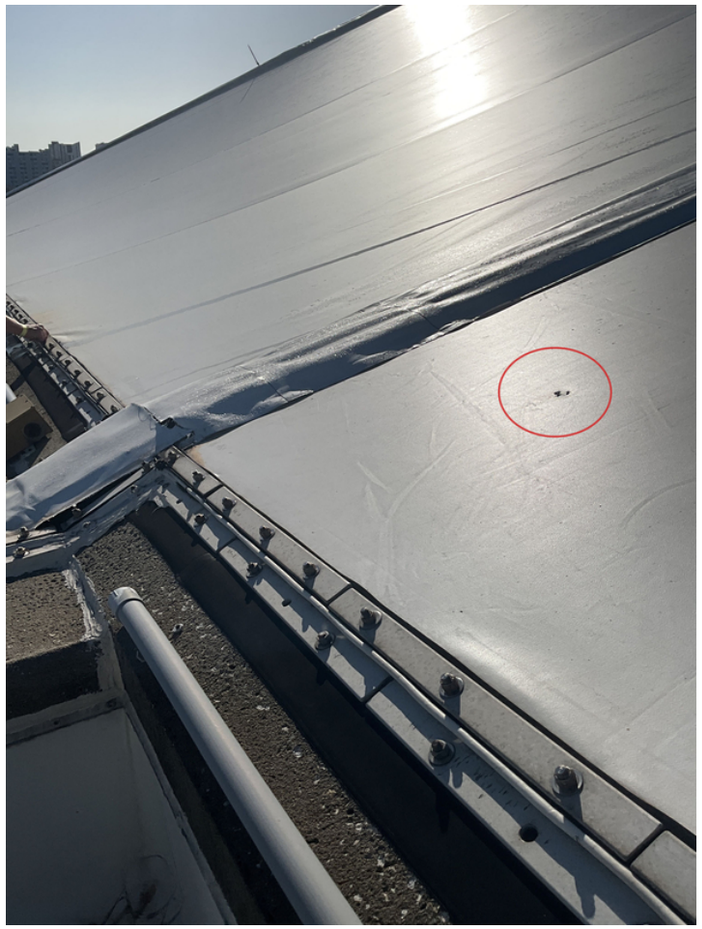
Pin	Issue ID	Description	Location Detail	Status	Company	Type	Date Created	Due Date
3	000074	Fabric tear in remaining panel.		Open	<not set>	Issue - Fabric	23 Oct 2024

1. We recommend that the dome be covered in all new outer fabric panels. This includes replacement of the existing surviving 6 roof outer fabric panels.

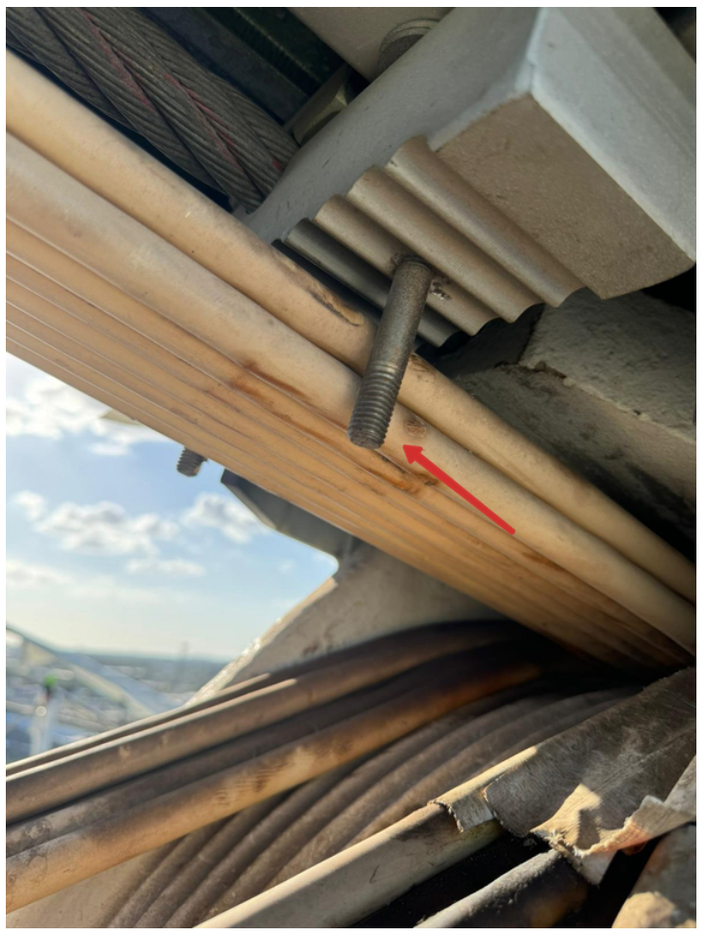
Pin	Issue ID	Description	Location Detail	Status	Company	Type	Date Created	Due Date
Issues without Pushpins								
	000084	Ridge clamp missing bottom plate. Photo was provided by rope access work. Location unknown.		Open	<not set>	Issue - Fabric	28 Oct 2024

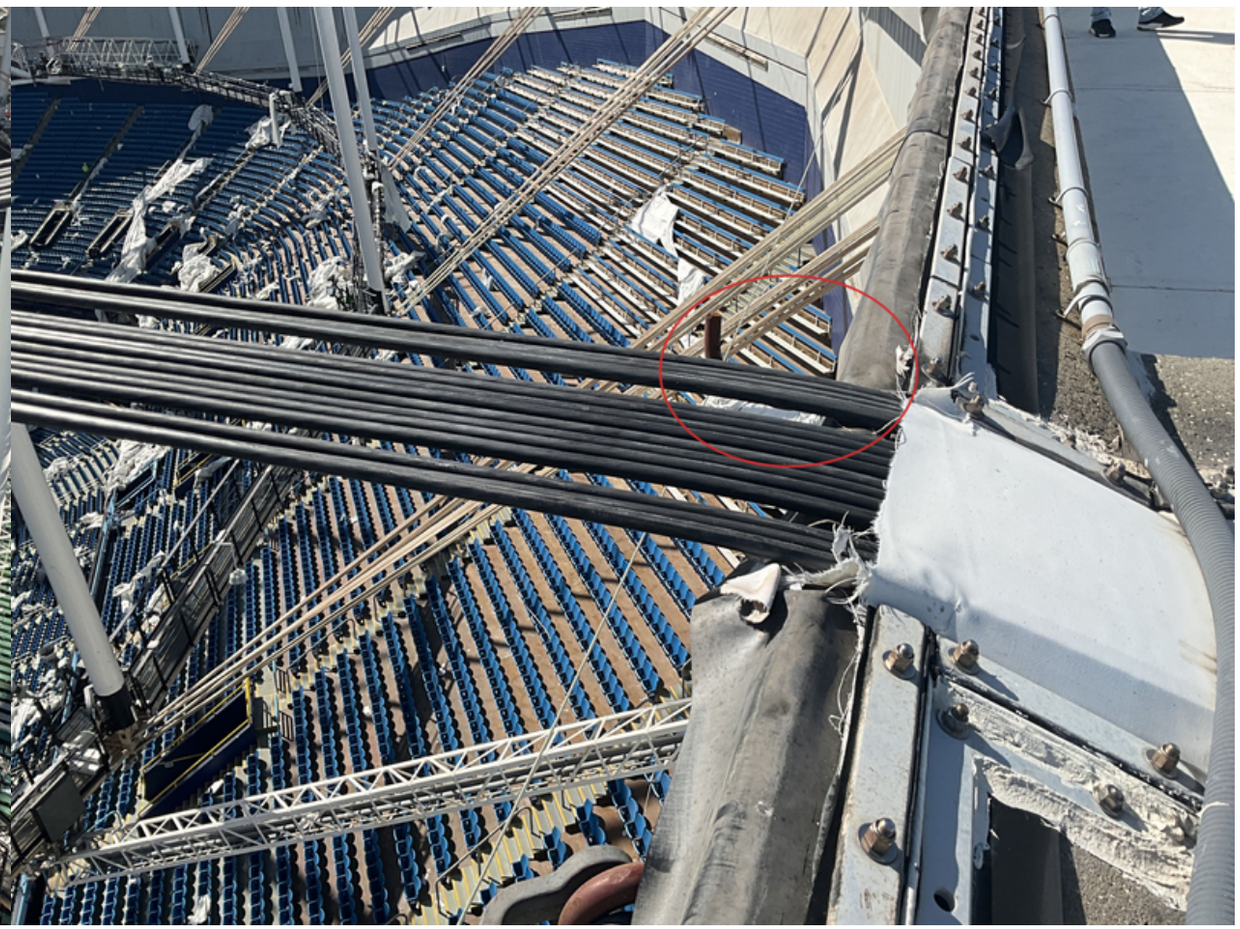
Observations: During Hurricane Milton, 14 out of 48 cables dislodged from the ring beam as a consequence of the cables' connections to the ringbeam having failed. The remaining cables and their connections to the ringbeam are considered suspect and will require strength validation if they are to remain in use. If the stadium roof is replaced, these failed cables will need to be reinstalled. For photos, refer to the "Cable Issues" section in Appendix 1.

Pin	Issue ID	Description	Location Detail	Status	Company	Type	Date Created	Due Date
1	000041	Ponding cable failure.		Open	<not set>	Issue - Cables	22 Oct 2024

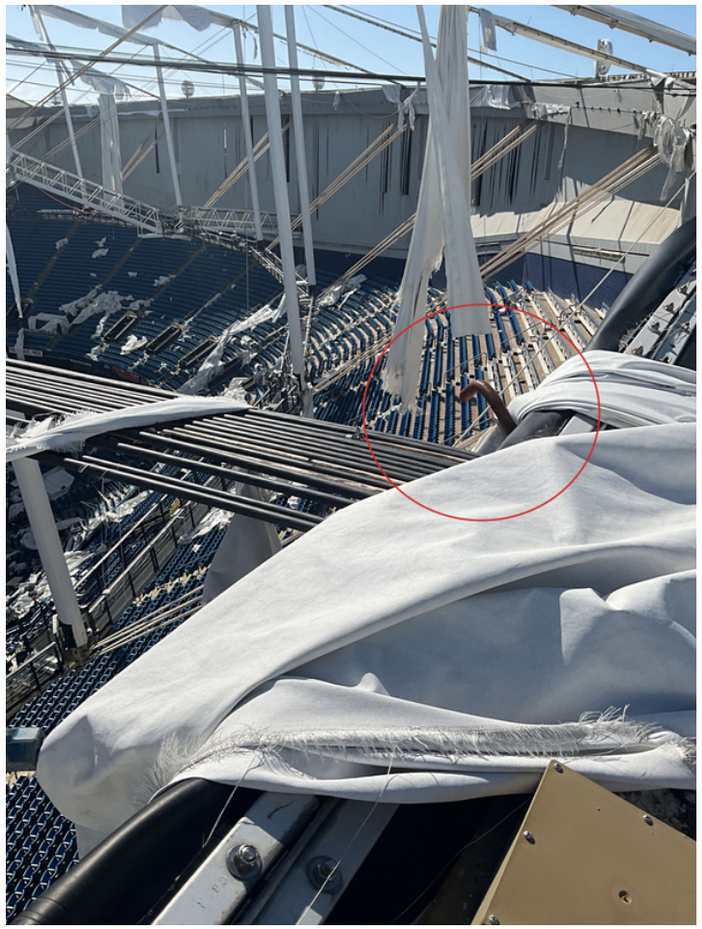
Pin	Issue ID	Description	Location Detail	Status	Company	Type	Date Created	Due Date
2	000042	Ponding cable failure.		Open	<not set>	Issue - Cables	22 Oct 2024

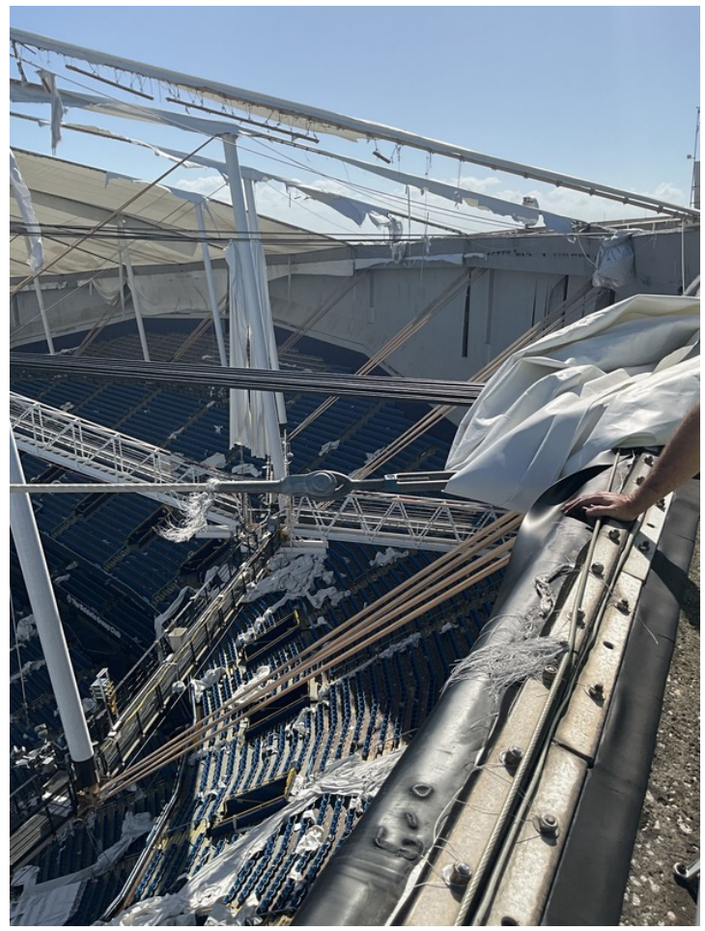
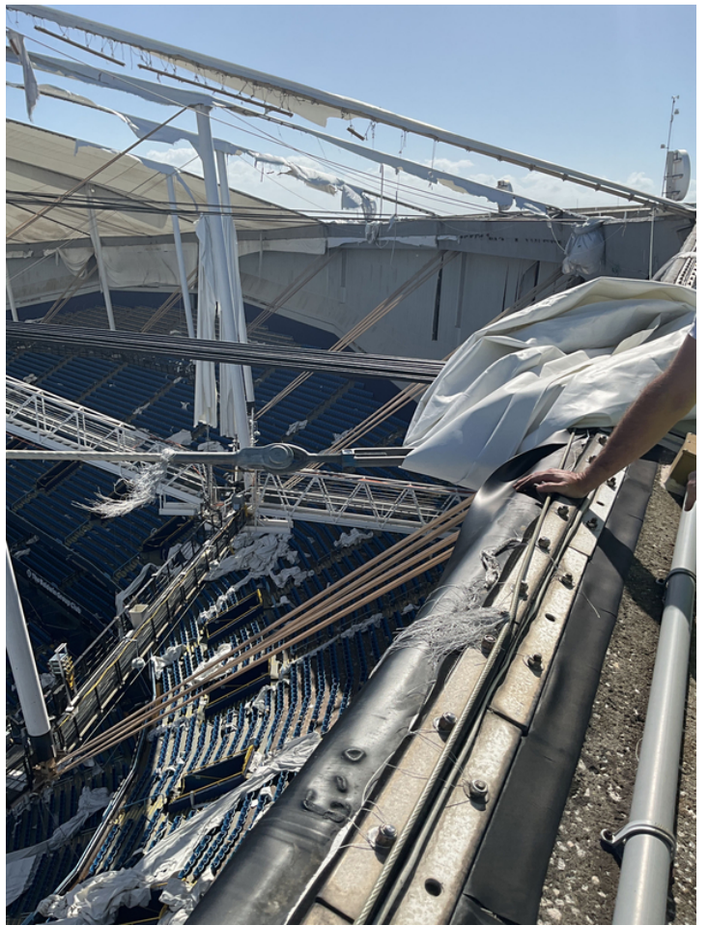
2024-10-22 11:38:22 Failed ponding cables draped over in tact cable

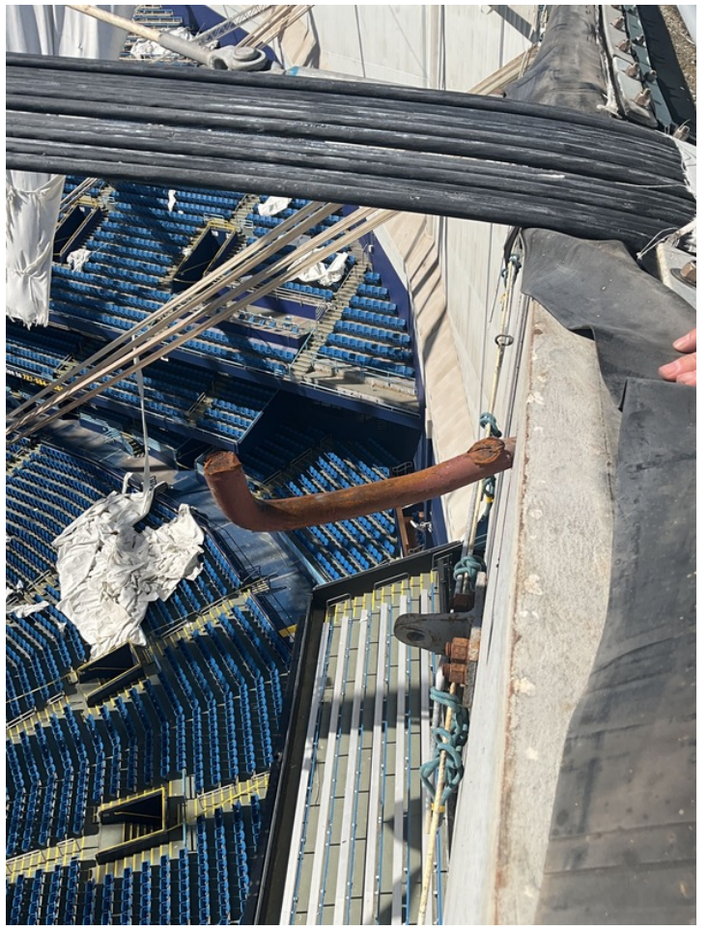
Pin	Issue ID	Description	Location Detail	Status	Company	Type	Date Created	Due Date
3	000038	Ponding cable failure.		Open	<not set>	Issue - Cables	22 Oct 2024

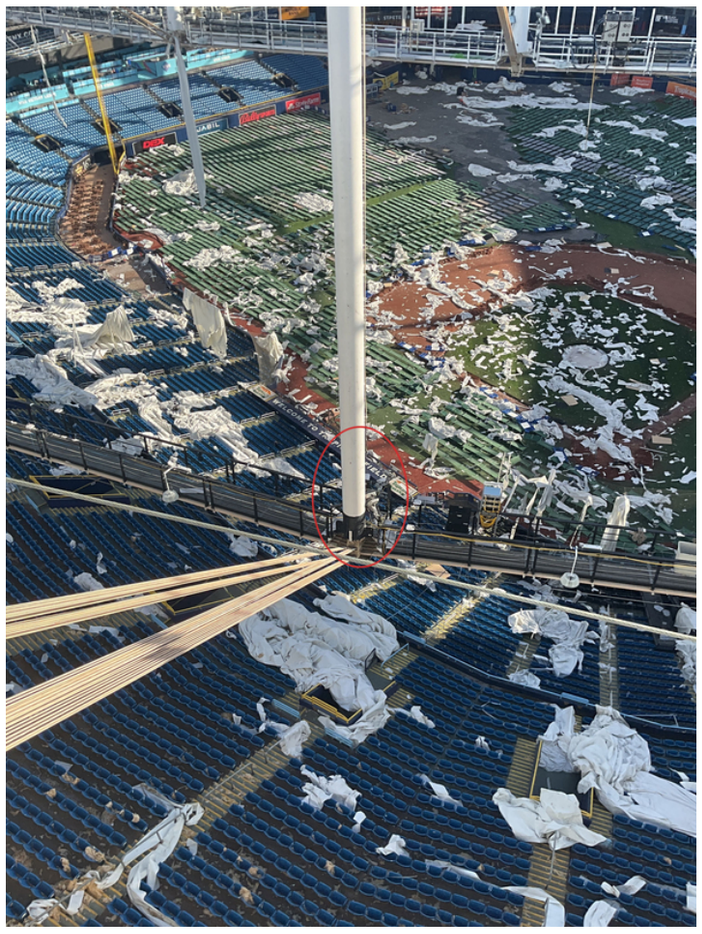
Observations: The steel tubes were inspected for straightness and signs of distress. No significant structural damage was observed. However, several struts sustained paint damage that should be repaired to prevent corrosion. For photos, refer to the "Steel Issues" section in Appendix 1.

Pin	Issue ID	Description	Location Detail	Status	Company	Type	Date Created	Due Date
2	000070	Chipped paint		Open	<not set>	Issue - Steel	23 Oct 2024

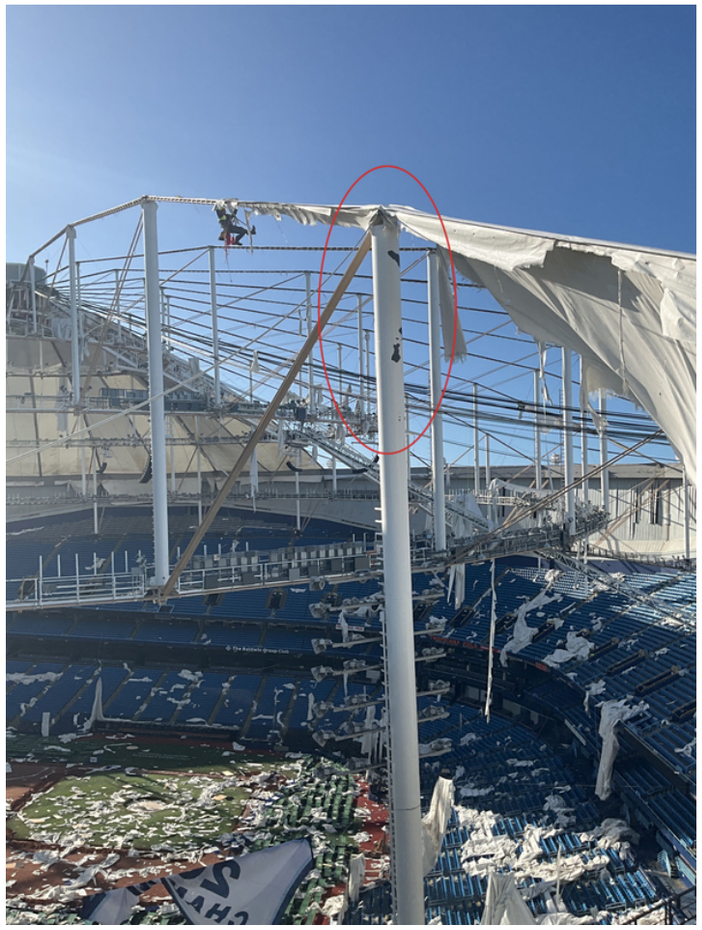
1	000073	Paint failure		Open	<not set>	Issue - Steel	23 Oct 2024

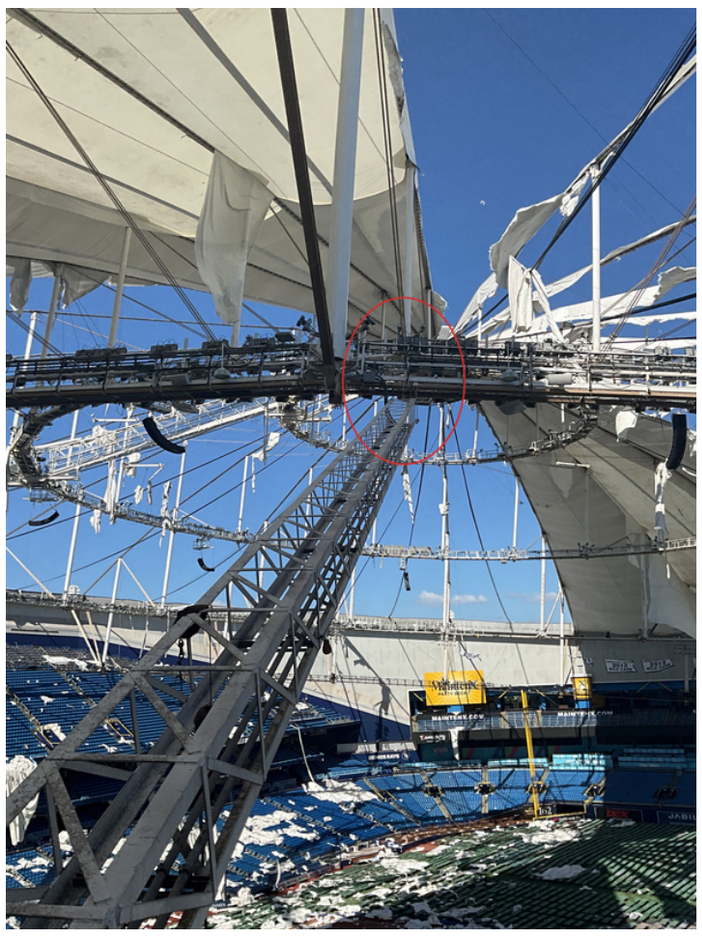
Observations: All cables in the tension rings were observed to be intact. A conduit bridge truss was observed to be supported by a single hanger rod and one of its "safety" cables. This connection should have at least 2 rods for redundancy. For photos, refer to the "Steel Issues" section in Appendix 1.

Pin	Issue ID	Description	Location Detail	Status	Company	Type	Date Created	Due Date
1	000079	Conduit truss hanging by single threaded rod. Note truss has safety cables in case rod fails.		Open	<not set>	Issue - Steel	23 Oct 2024

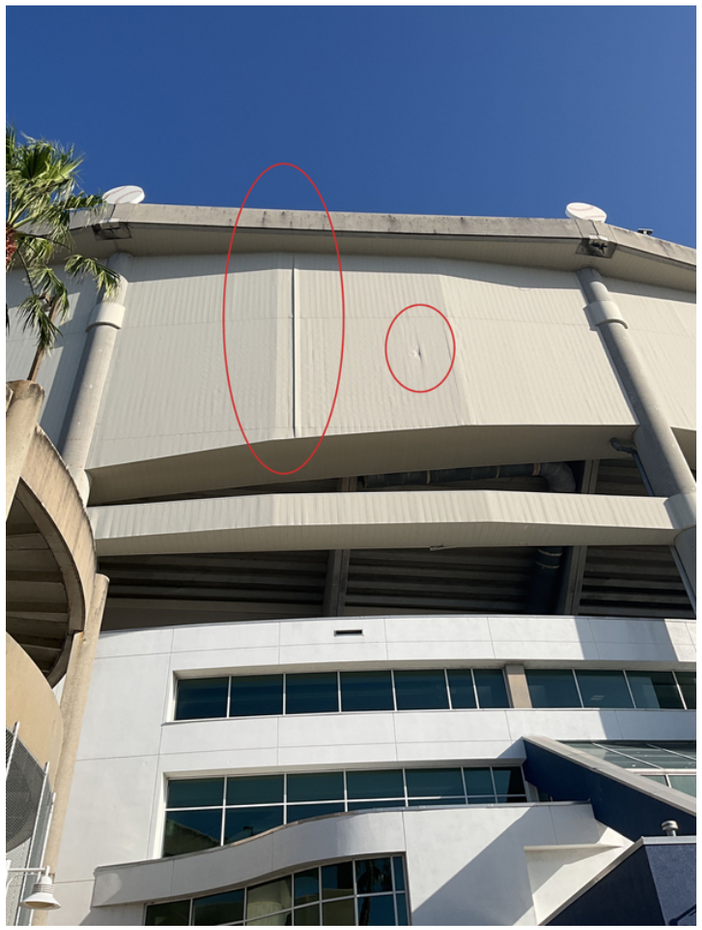
Pin	Issue ID	Description	Location Detail	Status	Company	Type	Date Created	Due Date
6	000010	Facade failure		Open	<not set>	Issue - Cladding	22 Oct 2024

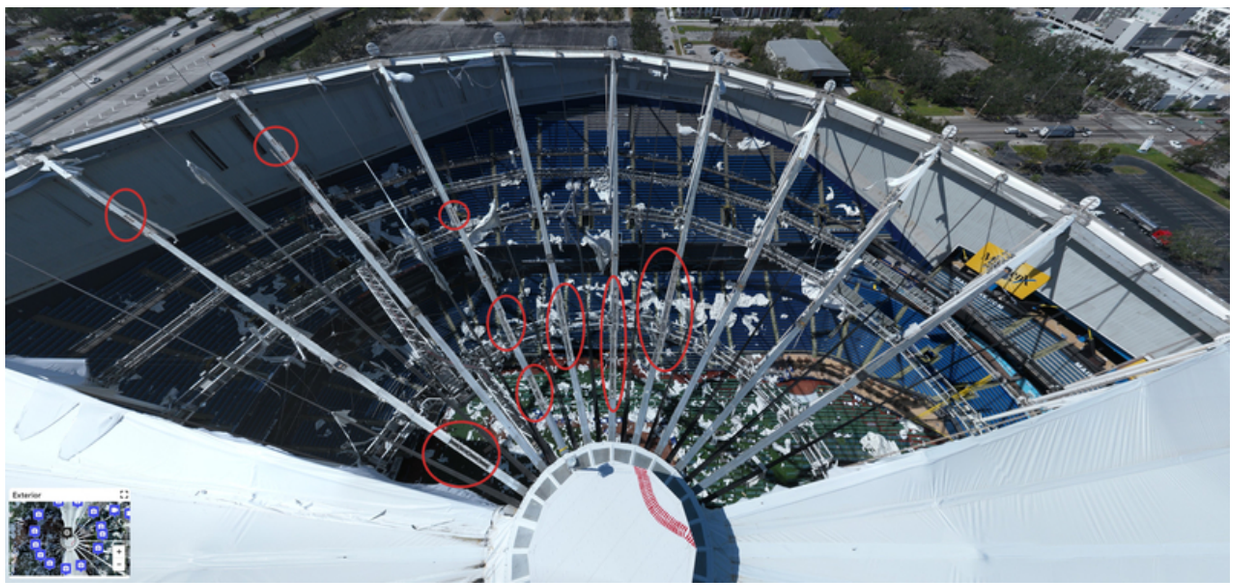
Pin	Issue ID	Description	Location Detail	Status	Company	Type	Date Created	Due Date
1	000082	Sheet metal cover plate missing for ridge cable clamping		Open	<not set>	Issue - Fabric	25 Oct 2024

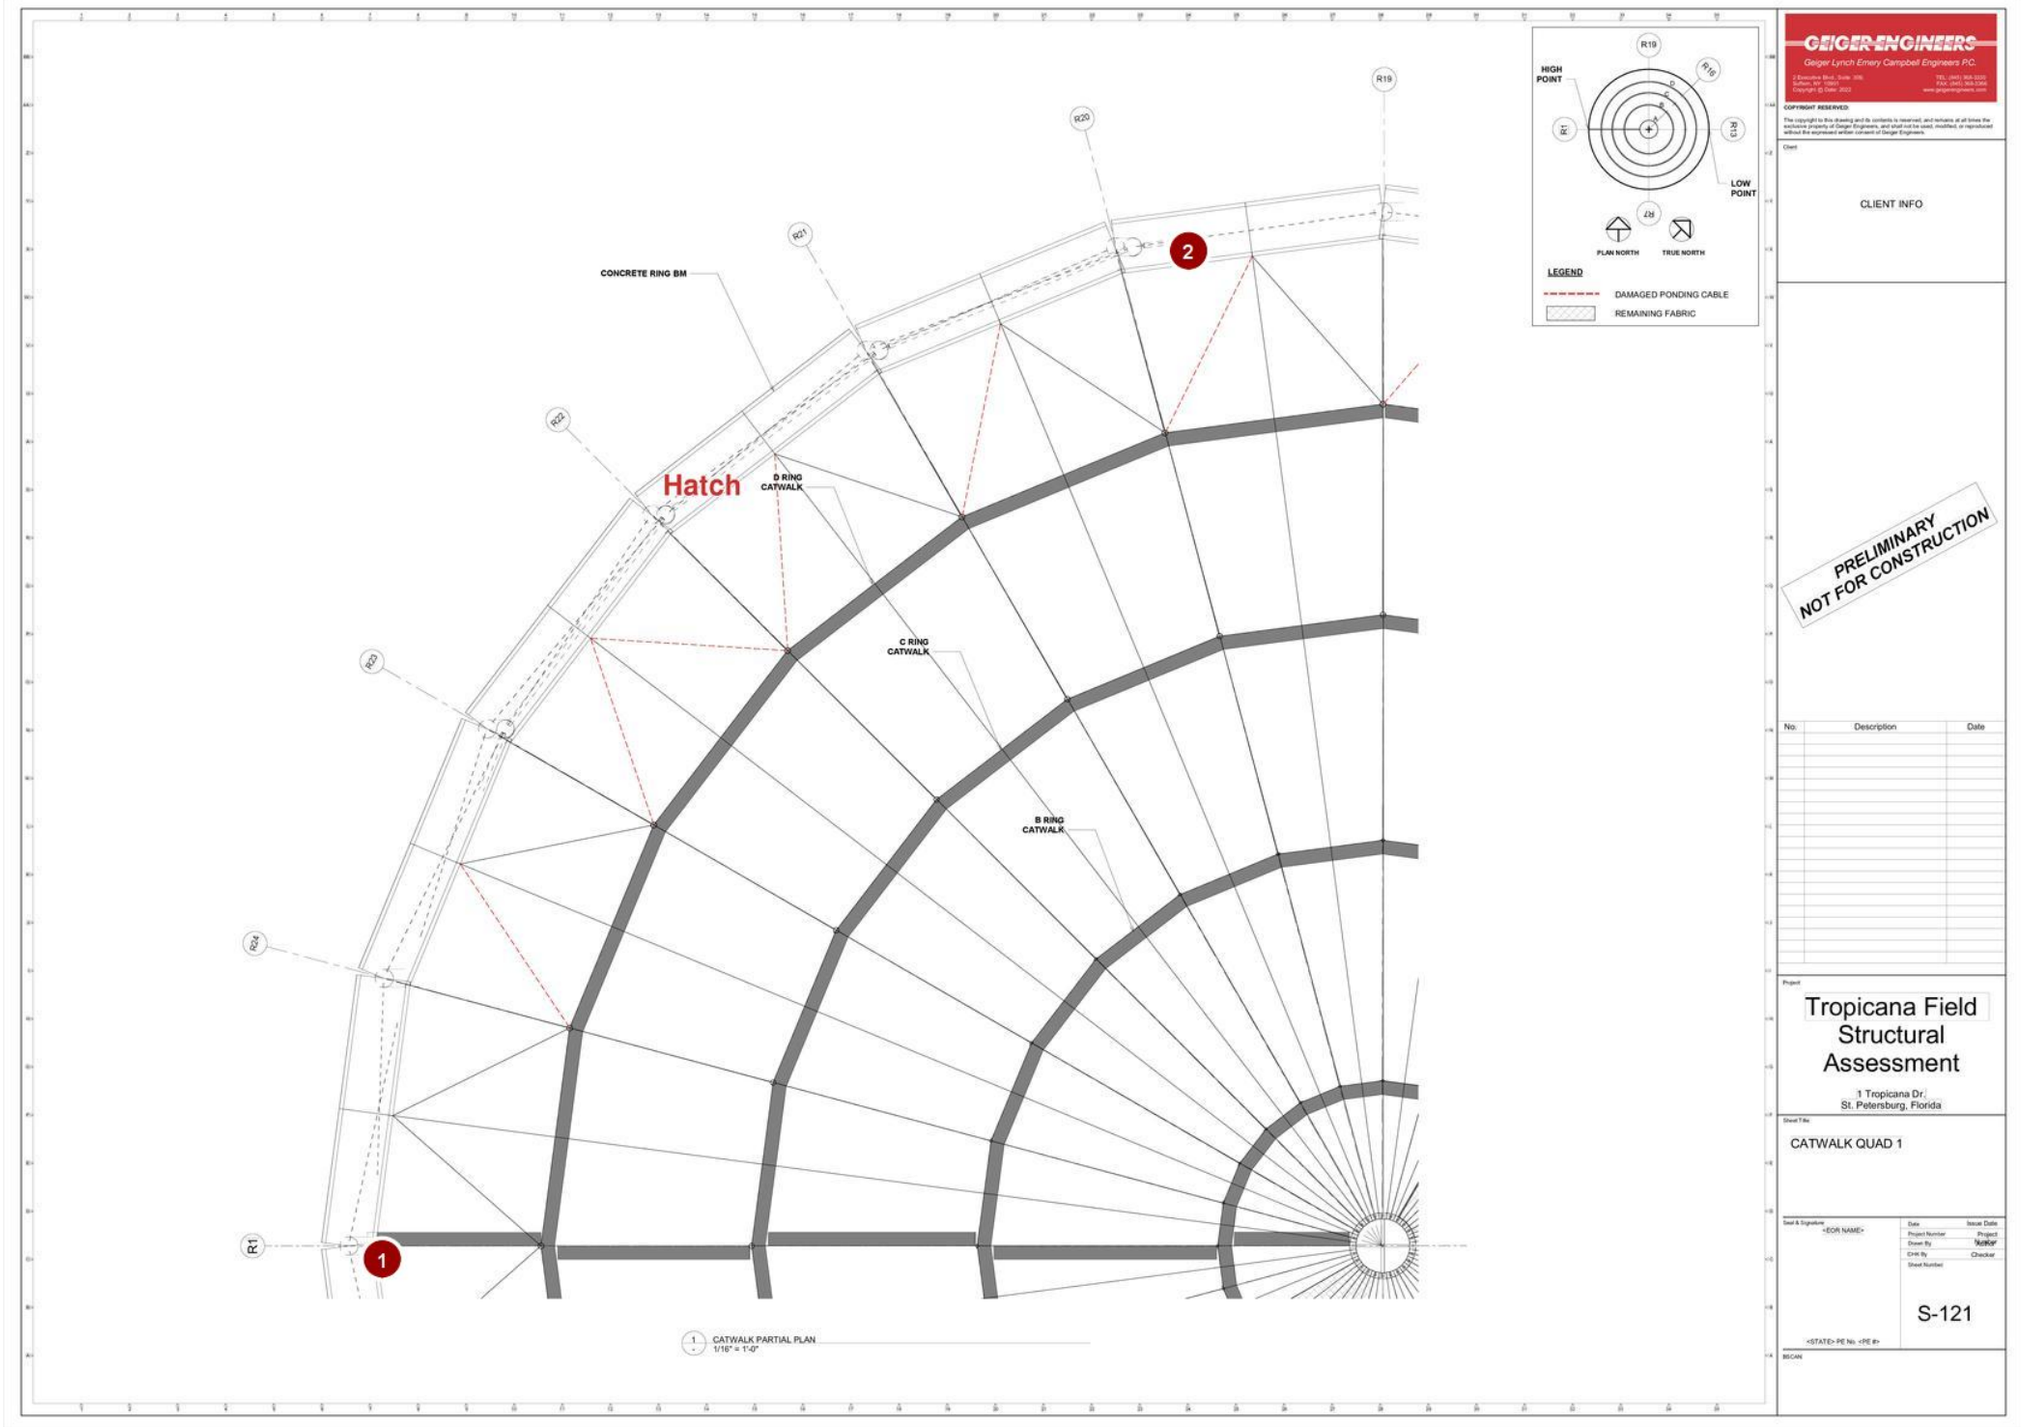
S-121 - CATWALK QUAD 1.pdf -

1	000048	Ring beam to fabric clamp failure.	Open	<not set>	Issue - Fabric	22 Oct 2024

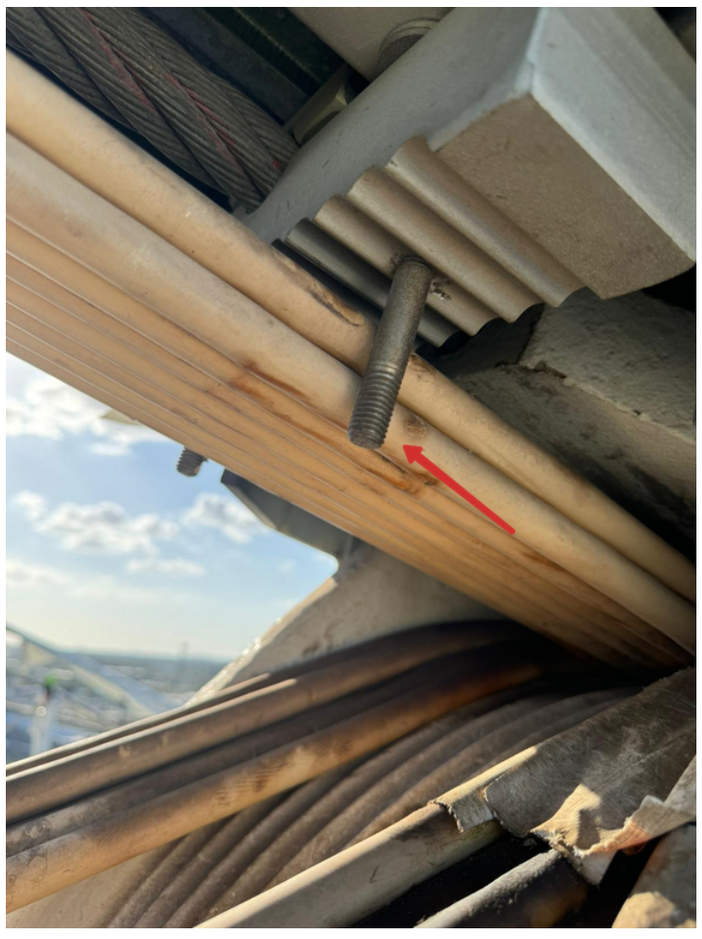
Pin	Issue ID	Description	Location Detail	Status	Company	Type	Date Created	Due Date
Issues without Pushpins								
	000084	Ridge clamp missing bottom plate. Photo was provided by rope access work. Location unknown.		Open	<not set>	Issue - Fabric	28 Oct 2024

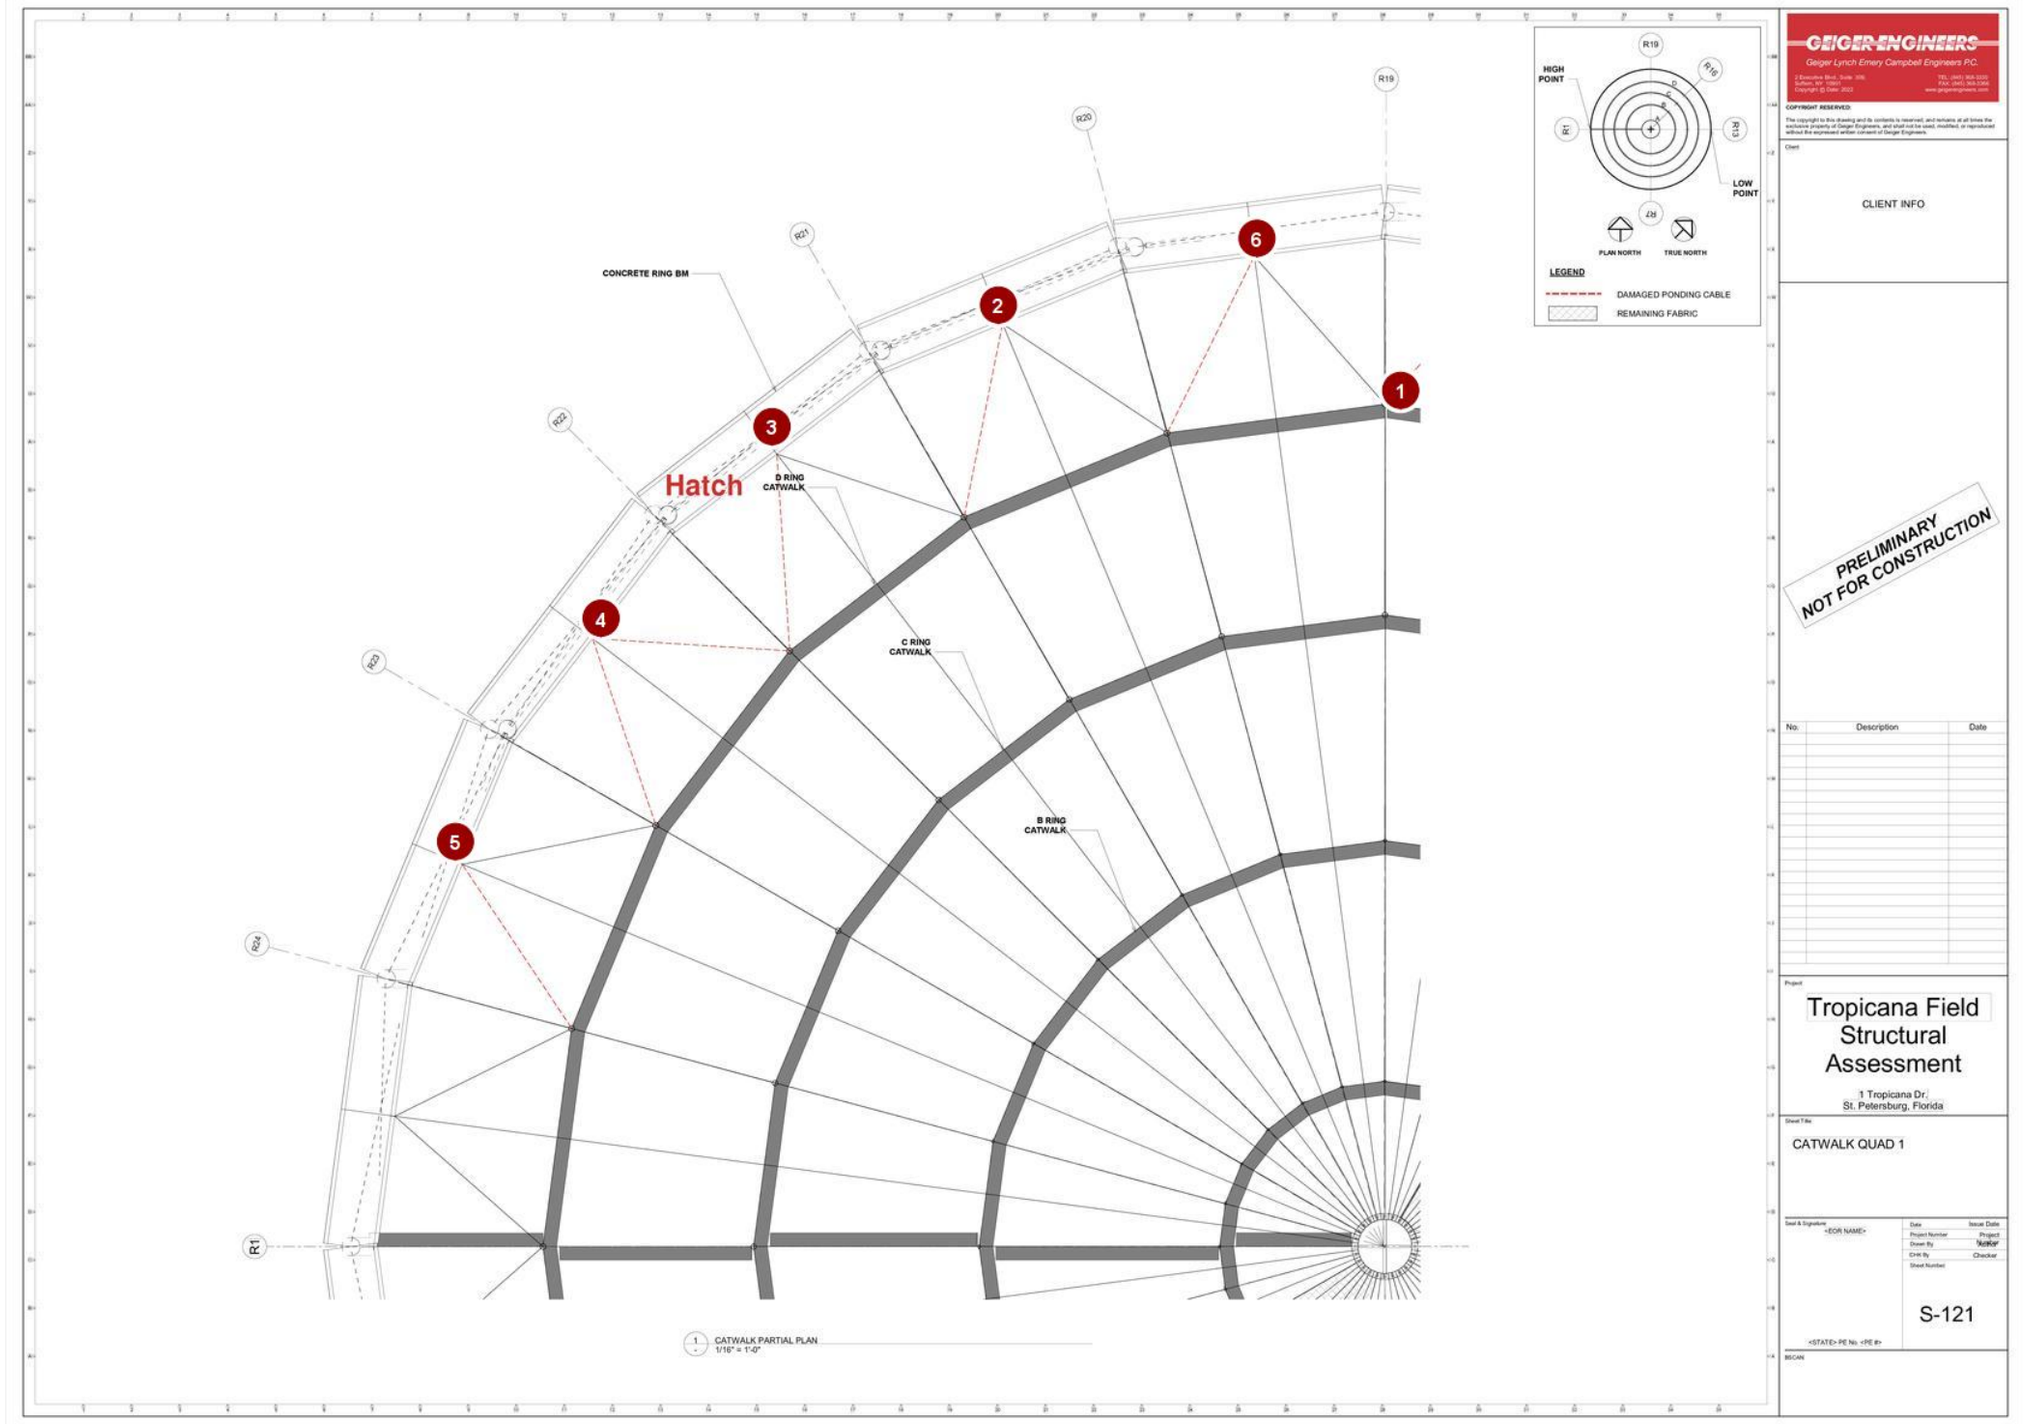
S-121 - CATWALK QUAD 1.pdf -

Pin	Issue ID	Description	Location Detail	Status	Company	Type	Date Created	Due Date
1	000041	Ponding cable failure.		Open	<not set>	Issue - Cables	22 Oct 2024

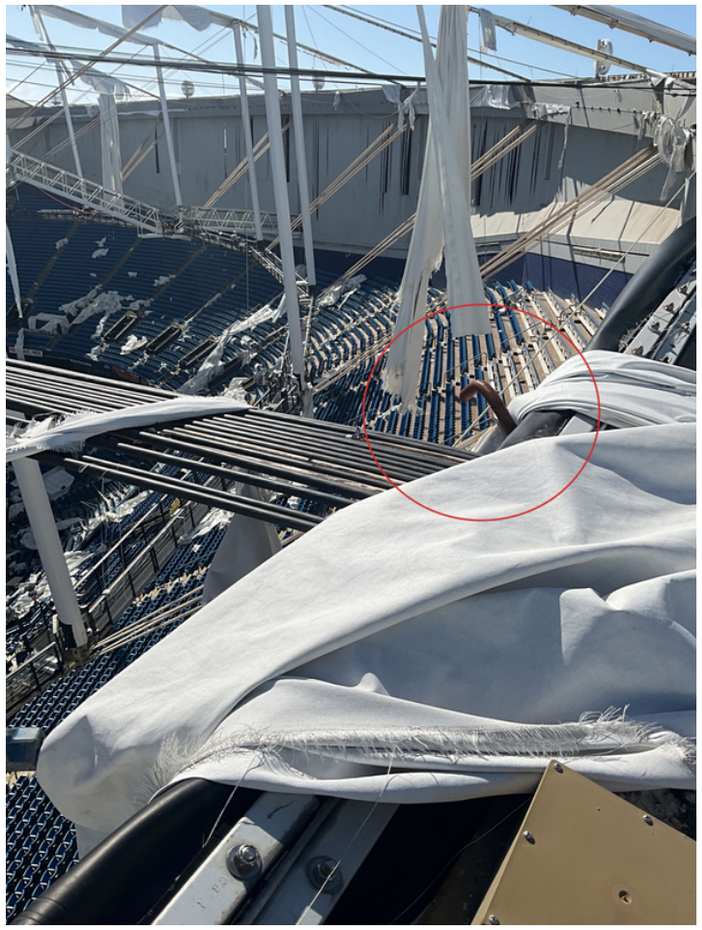
Pin	Issue ID	Description	Location Detail	Status	Company	Type	Date Created	Due Date
2	000042	Ponding cable failure.		Open	<not set>	Issue - Cables	22 Oct 2024

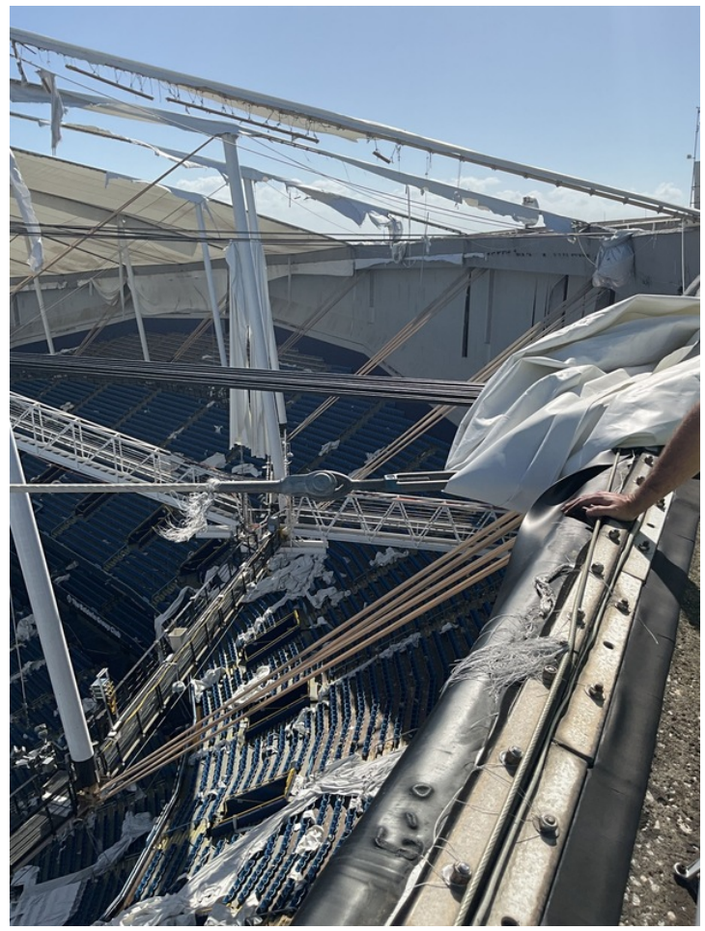
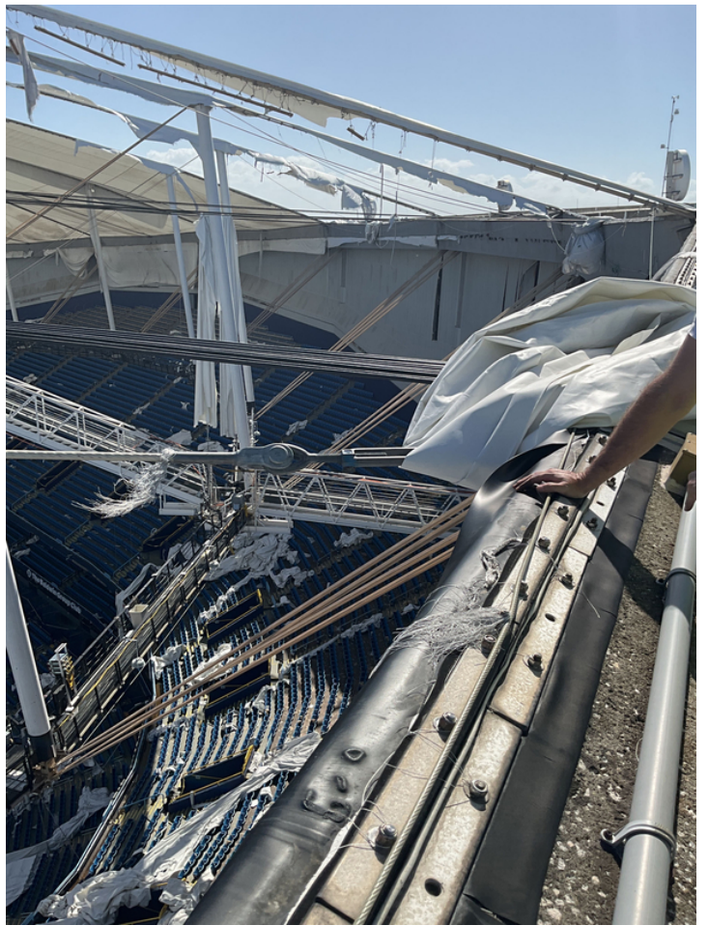
2024-10-22 11:38:22 Failed ponding cables draped over in tact cable

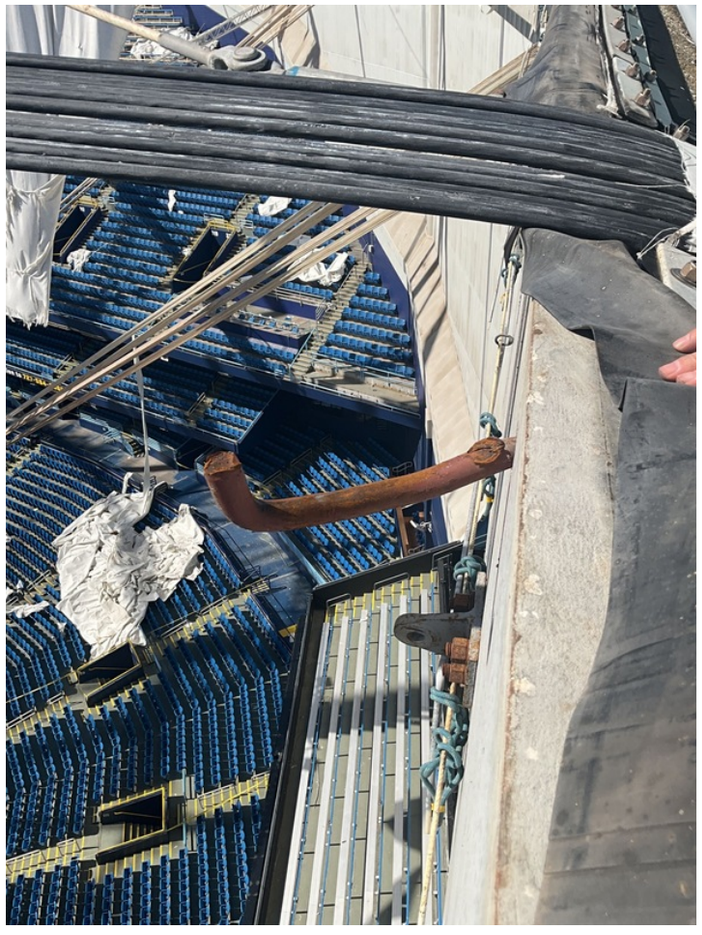
Pin	Issue ID	Description	Location Detail	Status	Company	Type	Date Created	Due Date
3	000038	Ponding cable failure.		Open	<not set>	Issue - Cables	22 Oct 2024
