Tropicana Field

Hurricane Milton Damage Assessment

November 11, 2024

Tropicana Field Roof
Structure Condition Assessment

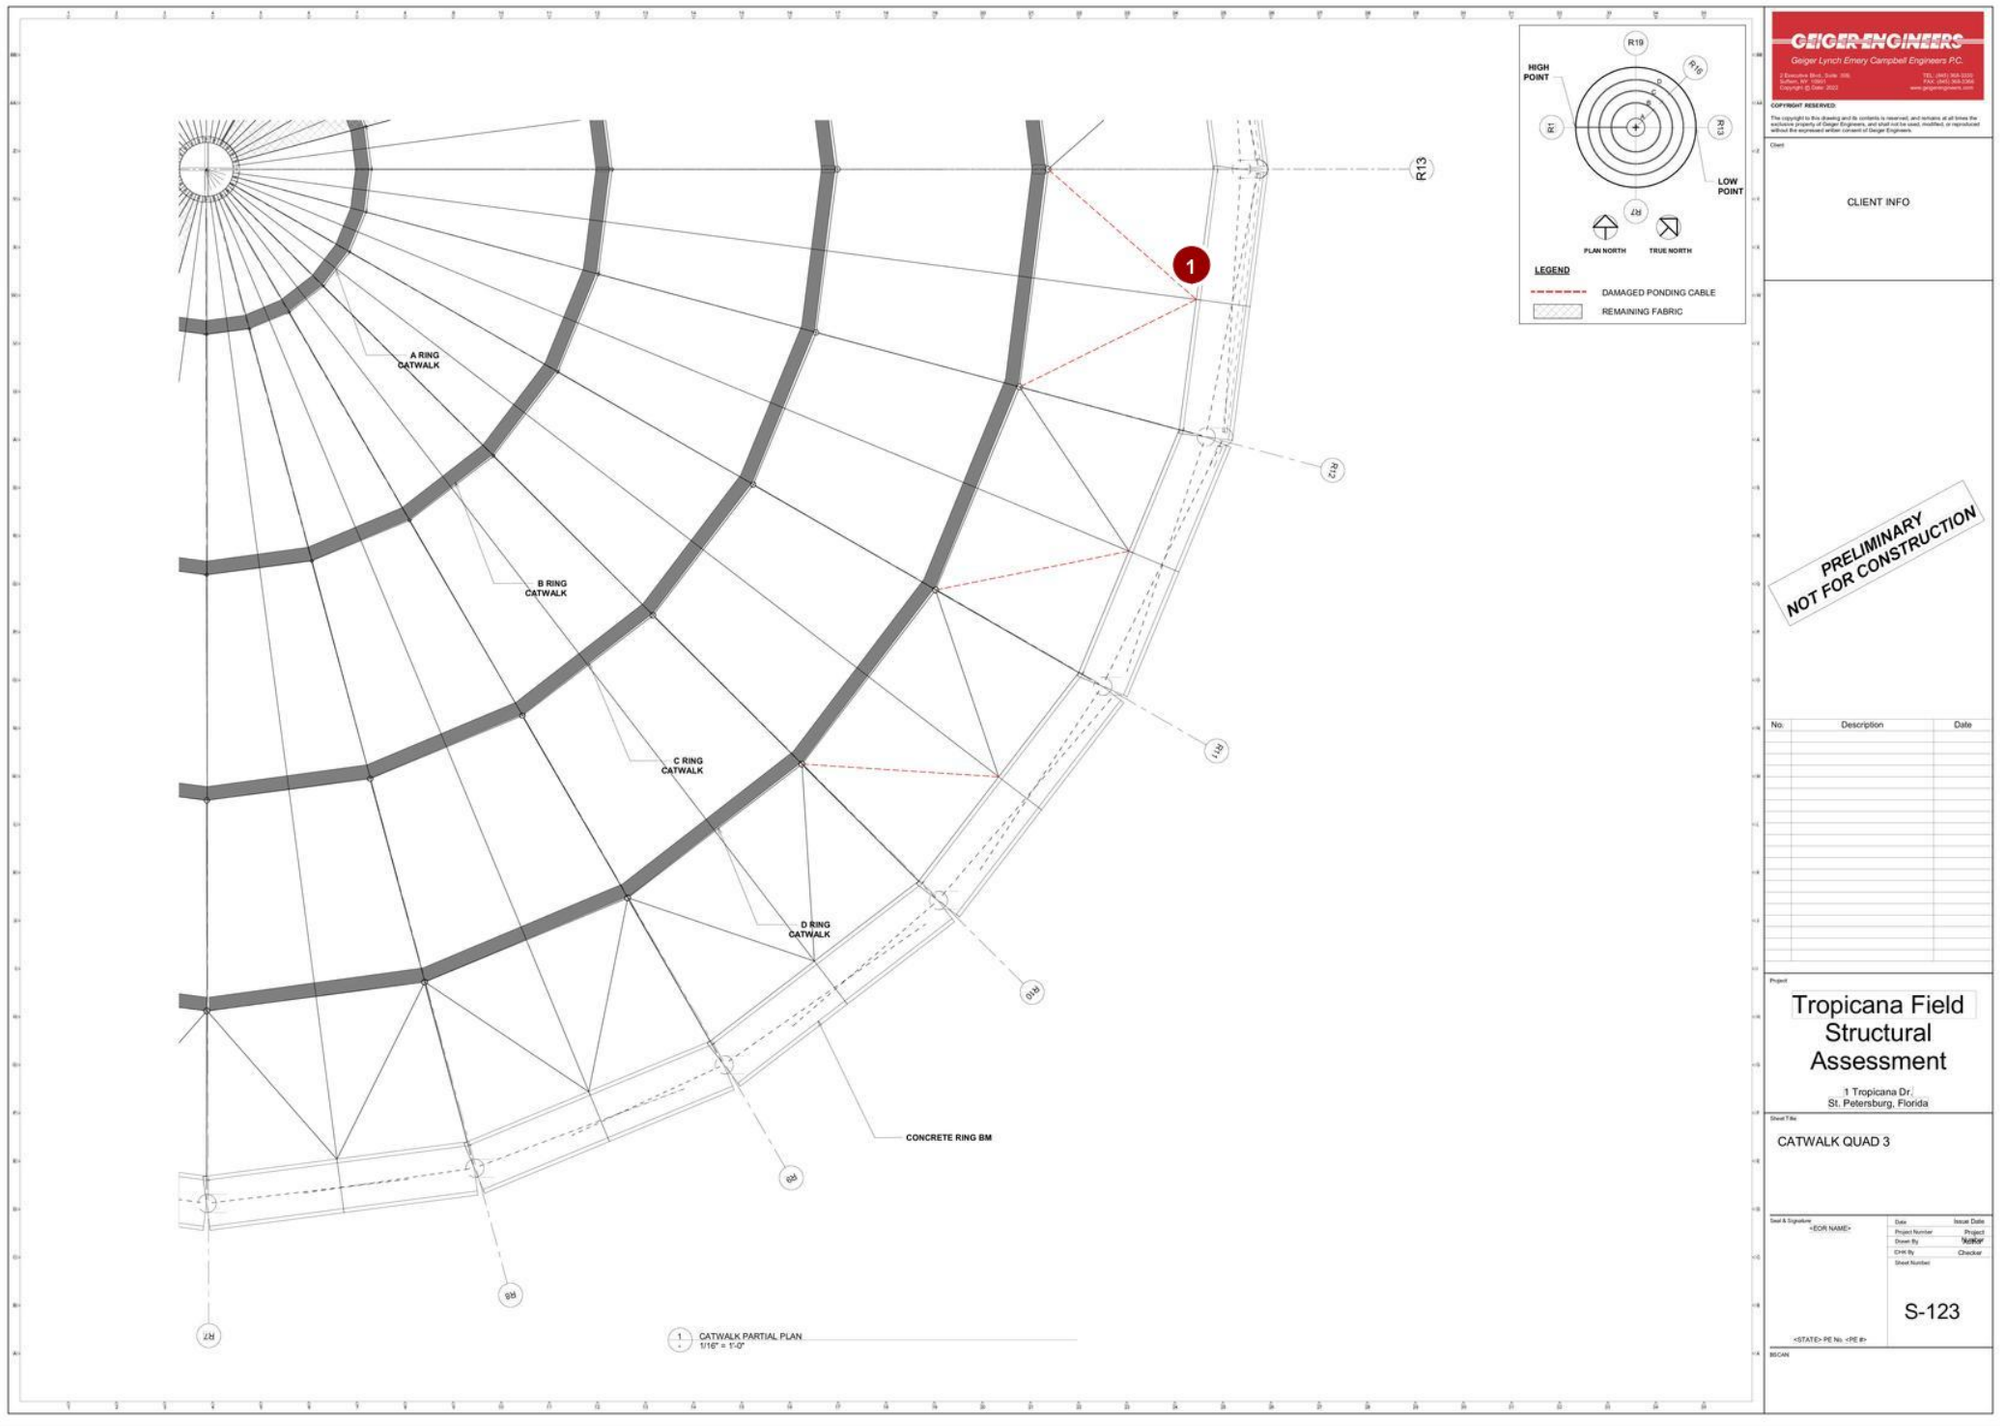
S-123 - CATWALK QUAD 3.pdf

1	000032	Ponding cable anchor fail		Open	<not set>	Issue - Cables	22 Oct 2024

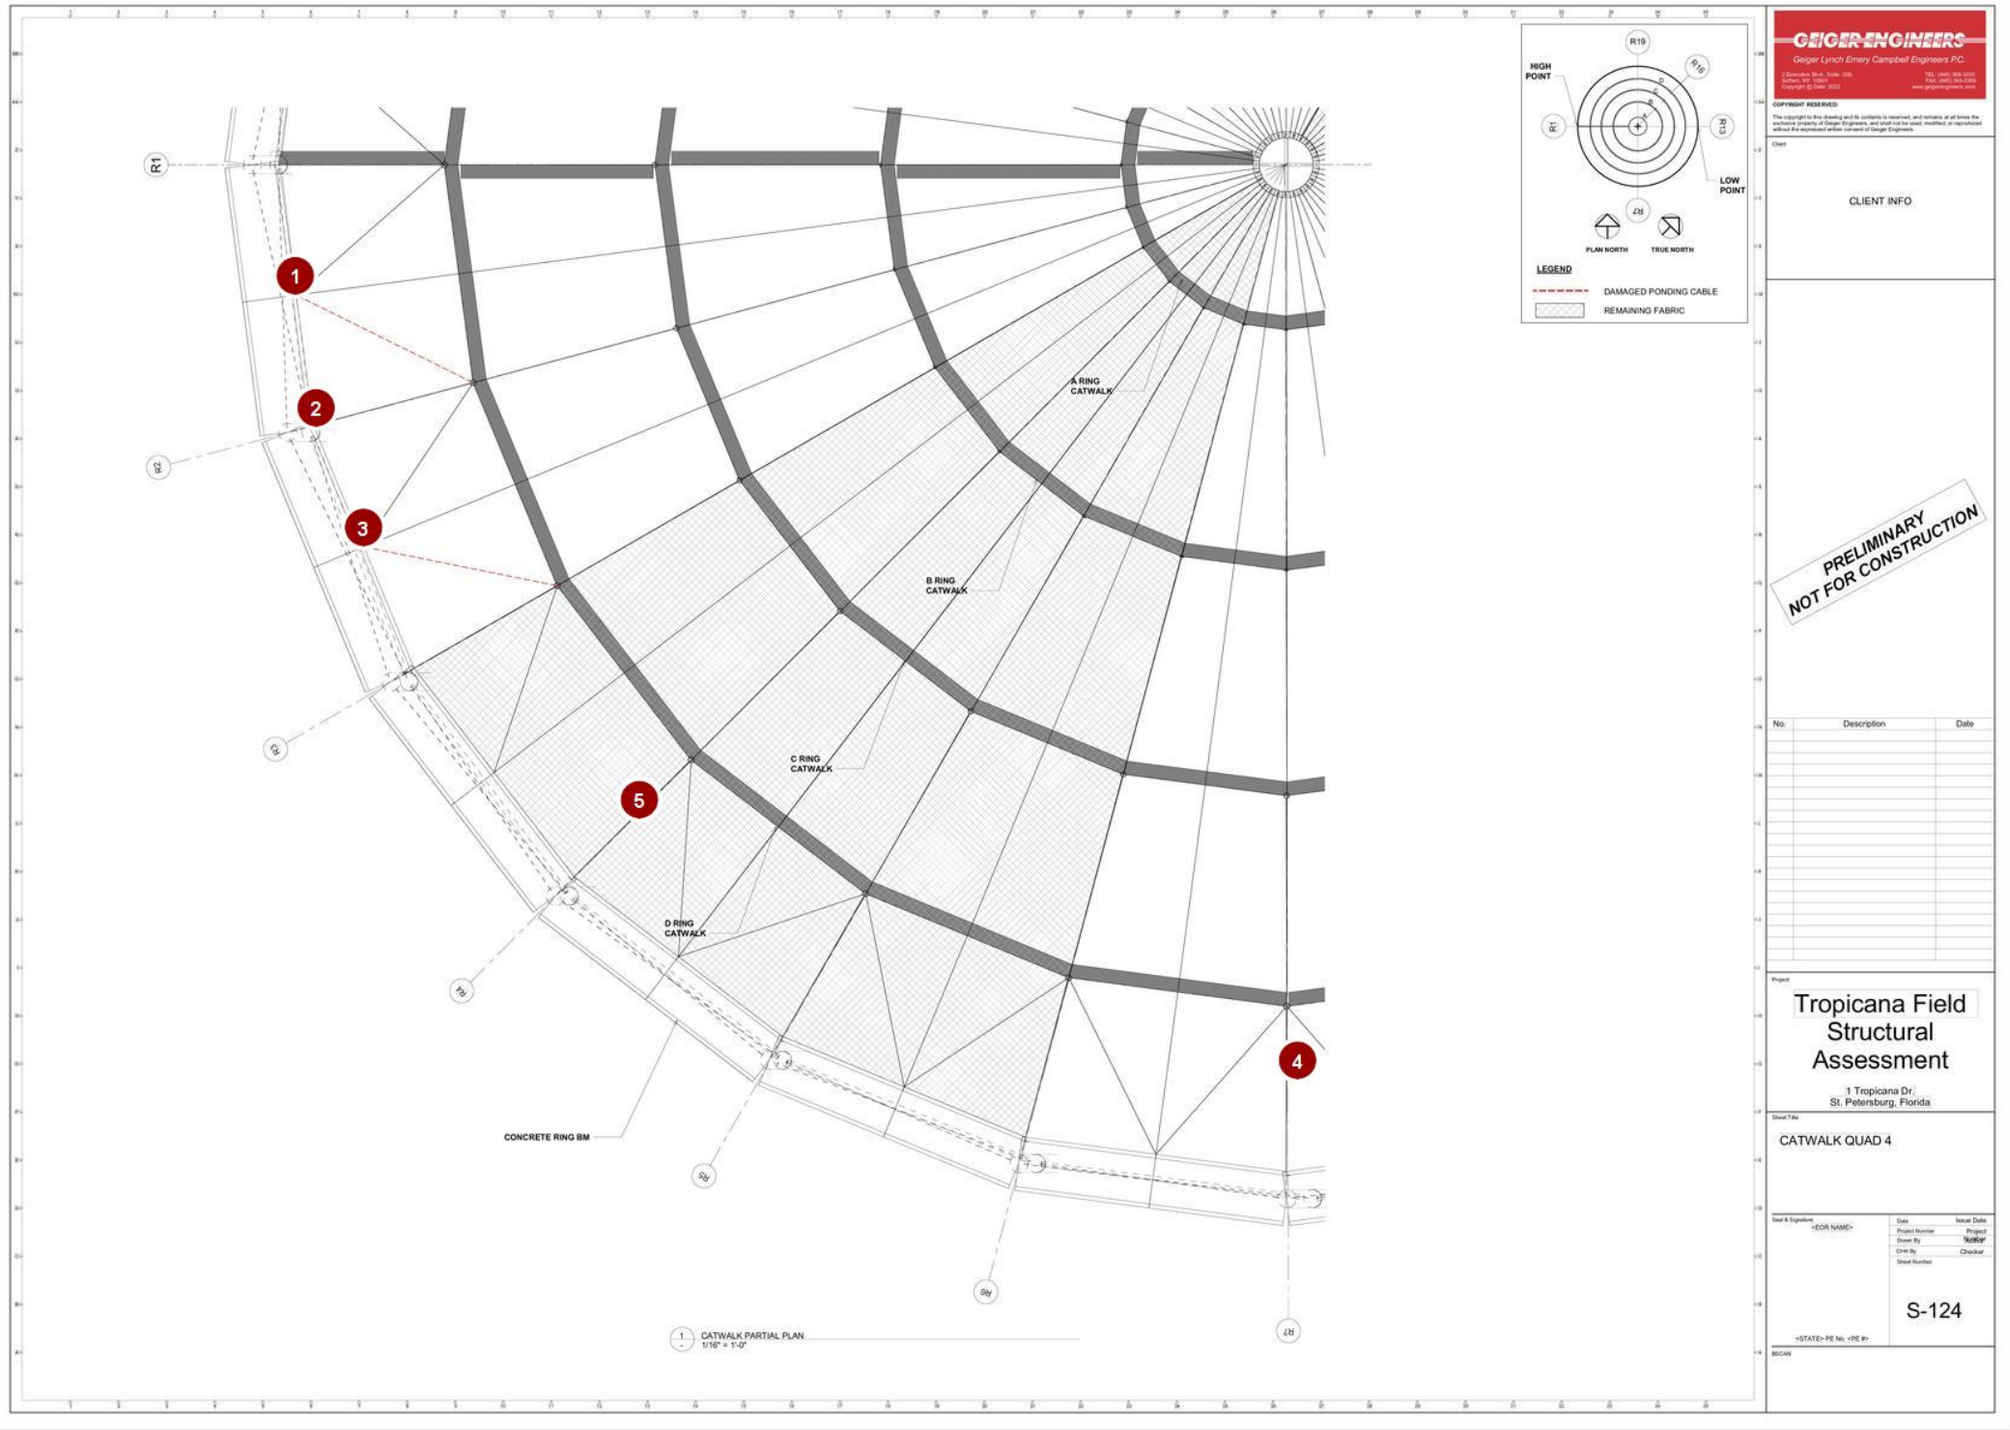
S-124 - CATWALK QUAD 4.pdf -

1	000049	Ponding cable fail	Open	<not set>	Issue - Cables	22 Oct 2024

Pin	Issue ID	Description	Location Detail	Status	Company	Type	Date Created	Due Date
2	000050	Ridge jacket fail		Open	<not set>	Issue - Cables	22 Oct 2024

Pin	Issue ID	Description	Location Detail	Status	Company	Type	Date Created	Due Date
3	000051	Ponding cable failure.		Open	<not set>	Issue - Cables	22 Oct 2024

Pin	Issue ID	Description	Location Detail	Status	Company	Type	Date Created	Due Date
4	000068	Sleeve of diagonal cable has become unsheathed. Coating needs to be replaced or cable will corrode.		Open	<not set>	Issue - Cables	22 Oct 2024

Pin	Issue ID	Description	Location Detail	Status	Company	Type	Date Created	Due Date
5	000078	Diagonal cable jacket failure. Conditions appears to have existing pre-hurricane.		Open	<not set>	Issue - Cables	23 Oct 2024

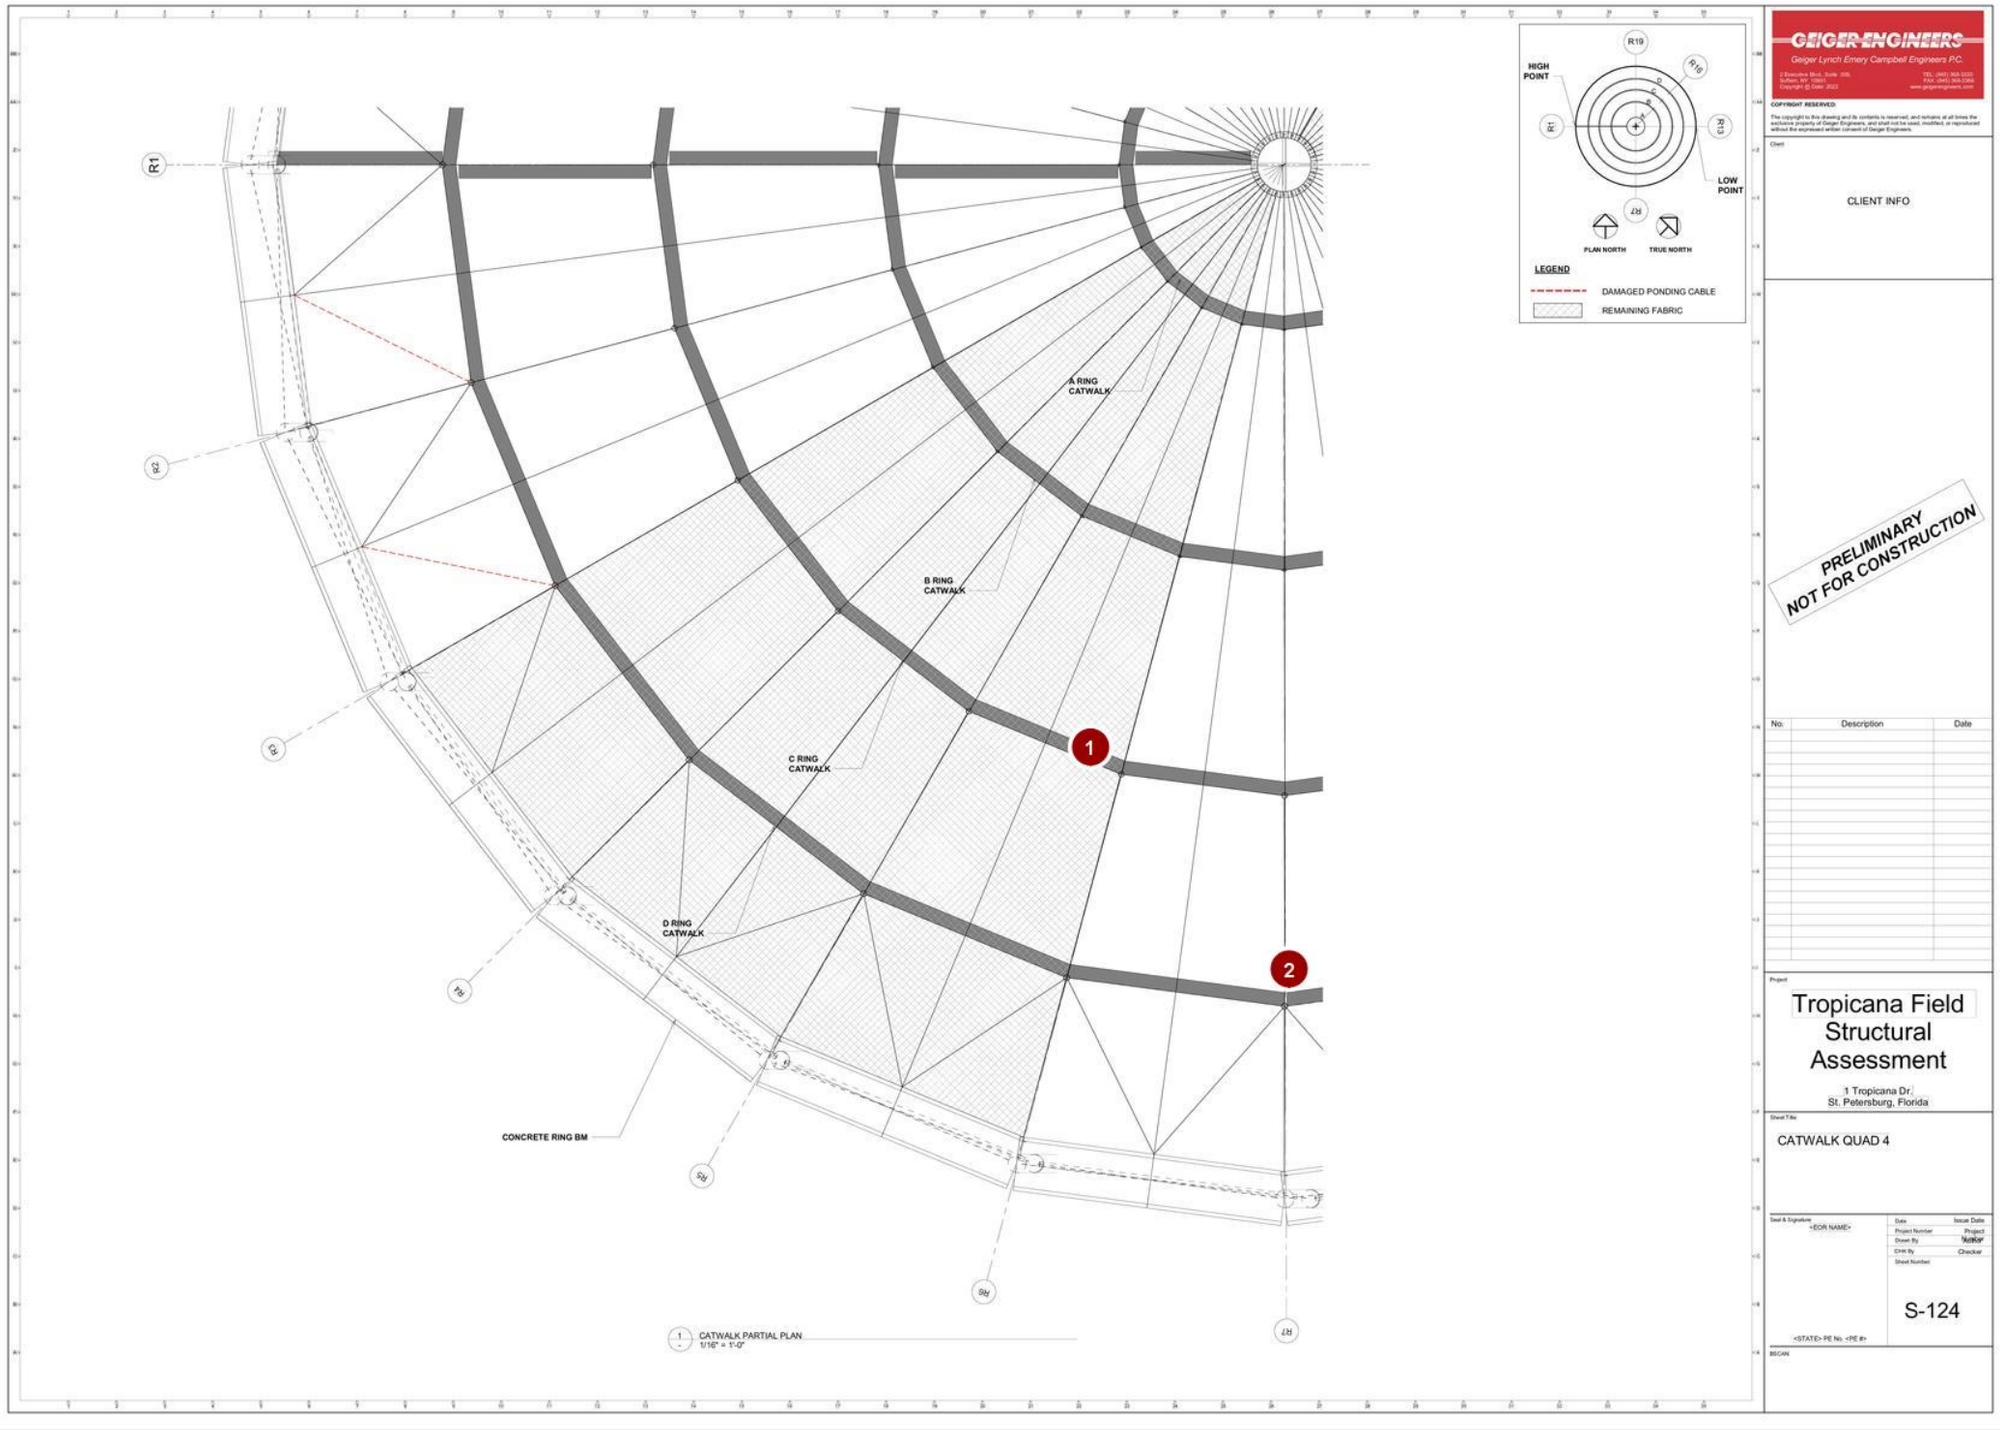
S-124 - CATWALK QUAD 4.pdf -

Pin	Issue ID	Description	Location Detail	Status	Company	Type	Date Created	Due Date
1	000079	Conduit truss hanging by single threaded rod. Note truss has safety cables in case rod fails.		Open	<not set>	Issue - Steel	23 Oct 2024

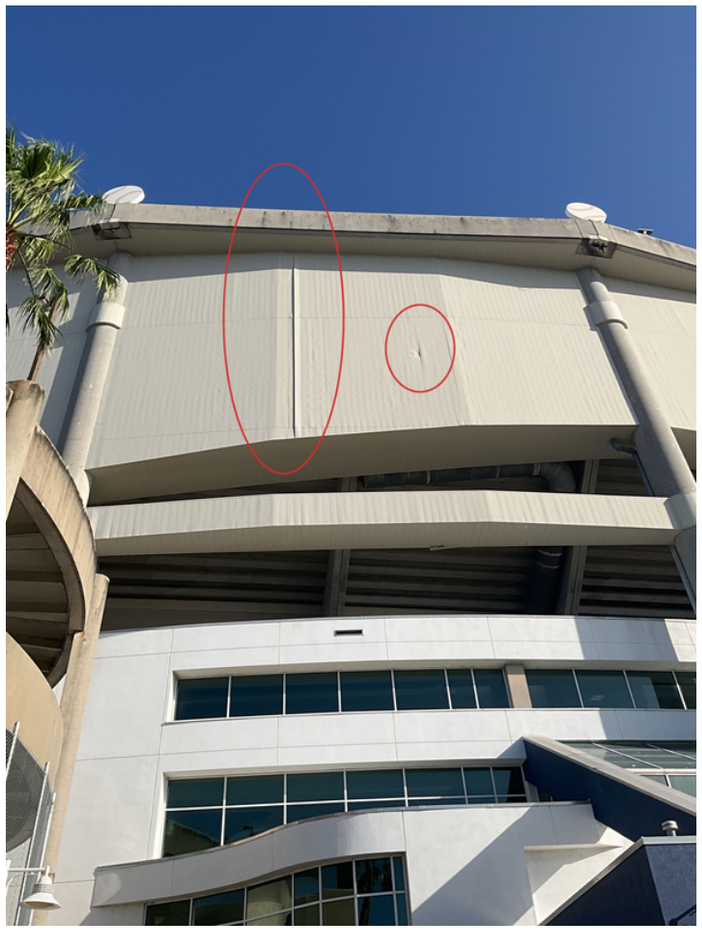
Pin	Issue ID	Description	Location Detail	Status	Company	Type	Date Created	Due Date
6	000010	Facade failure		Open	<not set>	Issue - Cladding	22 Oct 2024

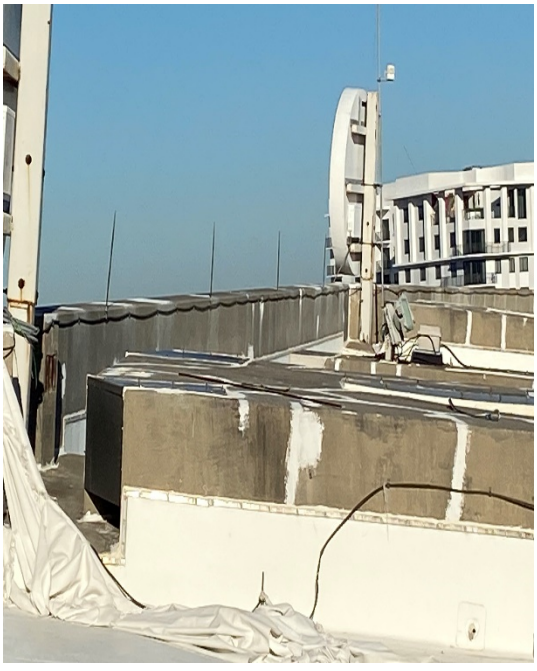
All South Lightening Protection reviewed the lightening protection system. Nearly all of the approximately 175 strike point locations attached to the 24 main cable bundles are missing and will need to be replaced. Over half of the strike points locations at the perimeter of the roof are missing and need to be replaced. The copper cable conductors for the system appears to be in place and functional. A full inspection and continuity test needs to be complete for a complete assessment.

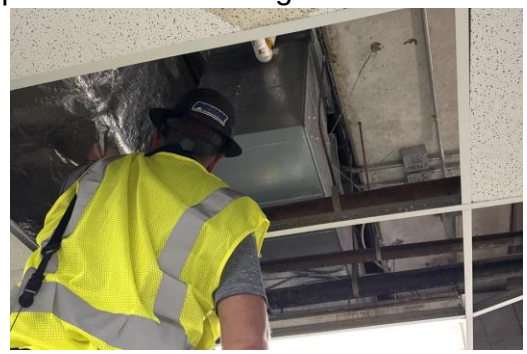
5 AHU's in mechanical spaces on Clubhouse level. Several are currently operational and conditioning the respective area. No noticeable damages in these areas or water intrusion noted beyond noted below. Typical water on floor from condensation or aged and poorly insulated chilled water piping and condensate drains. VFD's operational. The Uniform storage area directly shows the impact of above ceiling intrusion. Damage to ceiling visible.

RECOMMENDATION - This area is directly below the "at risk" location within the Dome Ring or roofing damaged area. Isolation of units and covering of the electrical and electronic components. Risk from above water drainage. No protection from above.

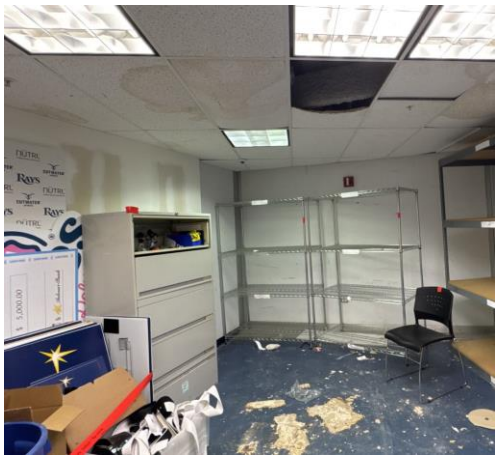
4th Floor Office and Storage Area

Air Handlers in this location found without impact or any visible signs of damage. Each AHU has an exhaust located within the room, also without damage or issue. There are several VAV boxes as well. No sign of damage to HVAC equipment. Evidence of water intrusion visible along drywall. Mildew in the area is present. Drywall/paint peeling in area.

RECOMMENDATION - This area is directly below the “at risk” location within the Dome Ring or roofing damaged area. Isolation of units and covering of the electrical and electronic components. Risk from above water drainage. No protection from above. Cover and contain this area. Repairs to the affected ducting and registers will be necessary after building made waterproof/dry.

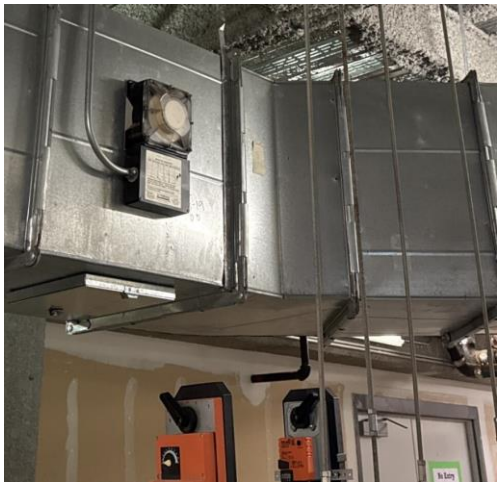
Gate 1 Mechanical Spaces

Units serve a substantial portion of the GATE 1 entry as well as the Guest areas leading into the seating stands. No water intrusion found. These areas are underneath a portion of the Northeast roof that attaches to the DOME RING wall. Areas very close to this location are fully exposed to the open Dome. Operation of these is open to the outdoors. Units are running currently.

RECOMMENDATION - This area is not directly below the "at risk" location within the Dome Ring or roofing damaged area BUT are very close. Soffit and facia are damaged just outside this are. Isolation of units and covering of the electrical and electronic components is recommended. Risk from above water drainage from outside the space into mechanical areas to be expected.

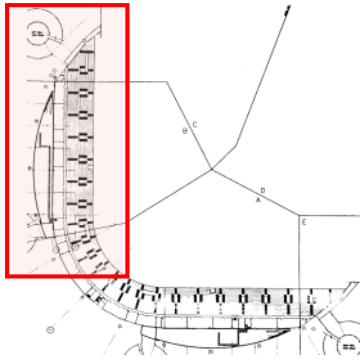
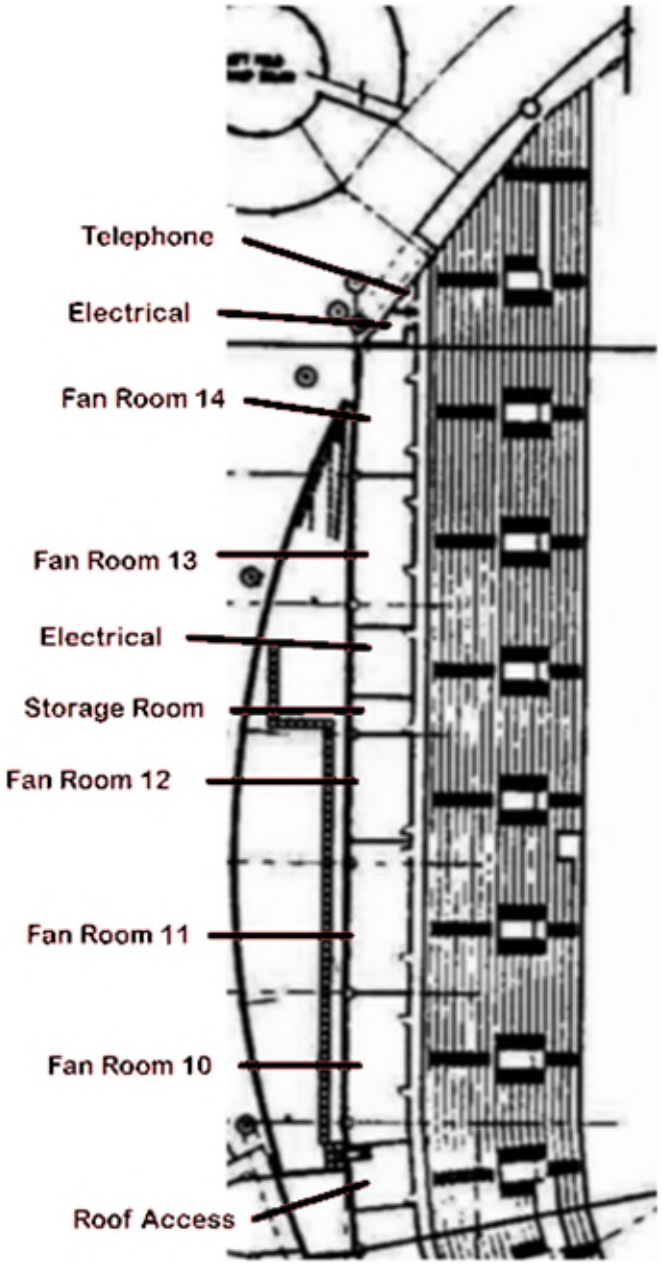
Upper Mechanical Level – West

No visible damages were observed at the time of EFI's assessment on October 21, 2024.
