Final Summary Report

Metallurgical Analysis of 42-Inch MVP Line H600 Hydrotest Elbow Fitting Failure (05/01/2024)

Mountain Valley Pipeline, LLC
Canonsburg, Pennsylvania

Report №: E-AD-LI / GTQU (10513119)
August 1, 2024

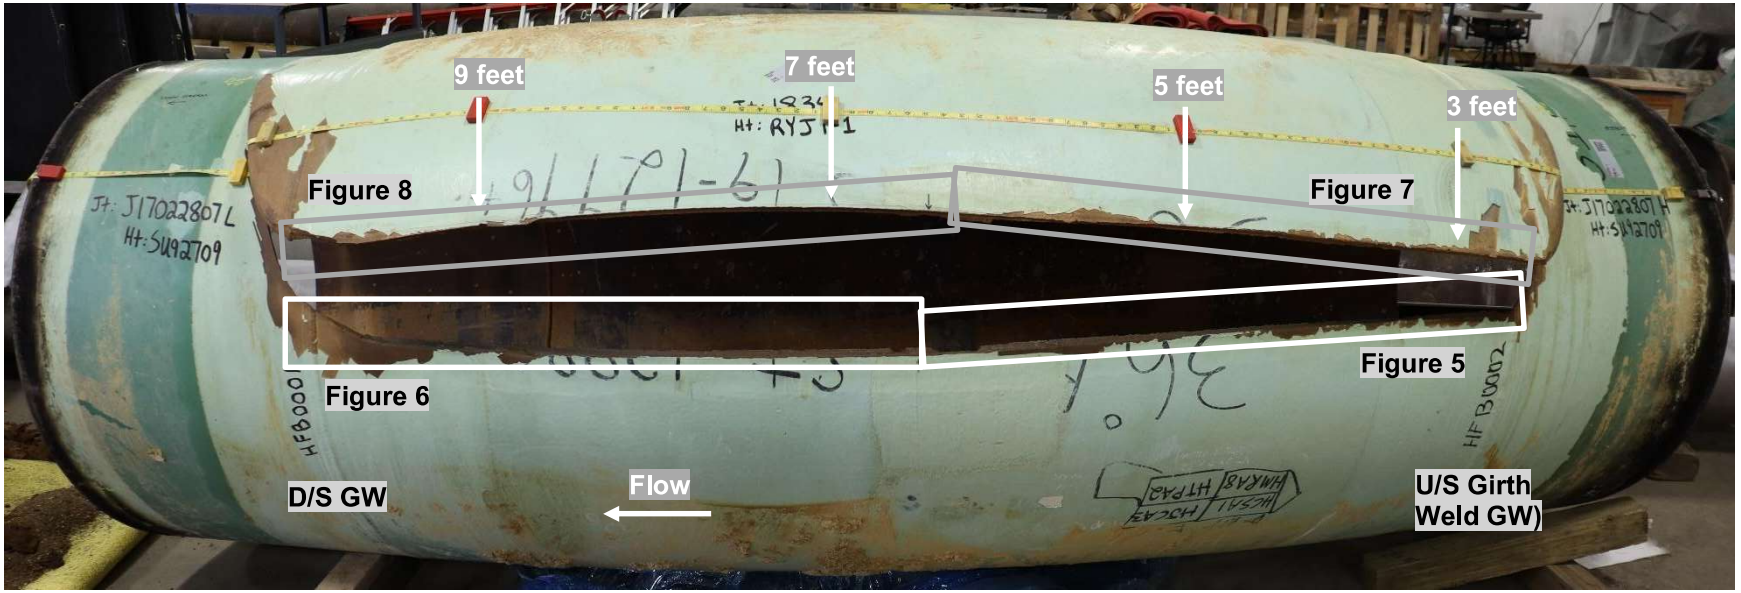
Figure 1. Photograph of the pipe section as received at DNV, after unloading. The pipe section was wrapped with plastic and tarps, with the ends sealed. The fracture surfaces were protected with foam tubing insulation. Typical of pipeline construction, various labels were written on the external pipe surface, such as “Jt: J17022807H HT: SU92709, upstream, HFB0002, HCSA1, HJCA3, HMRA8, HTPA2, 36°, Jt: 1834 Ht: RYJ1-1, HFB0001, Jt: J17022807L Ht: SU92709, downstream, TDC, Jeeped 7-17-18, 2 of 3 JT sec, .740 36°”.

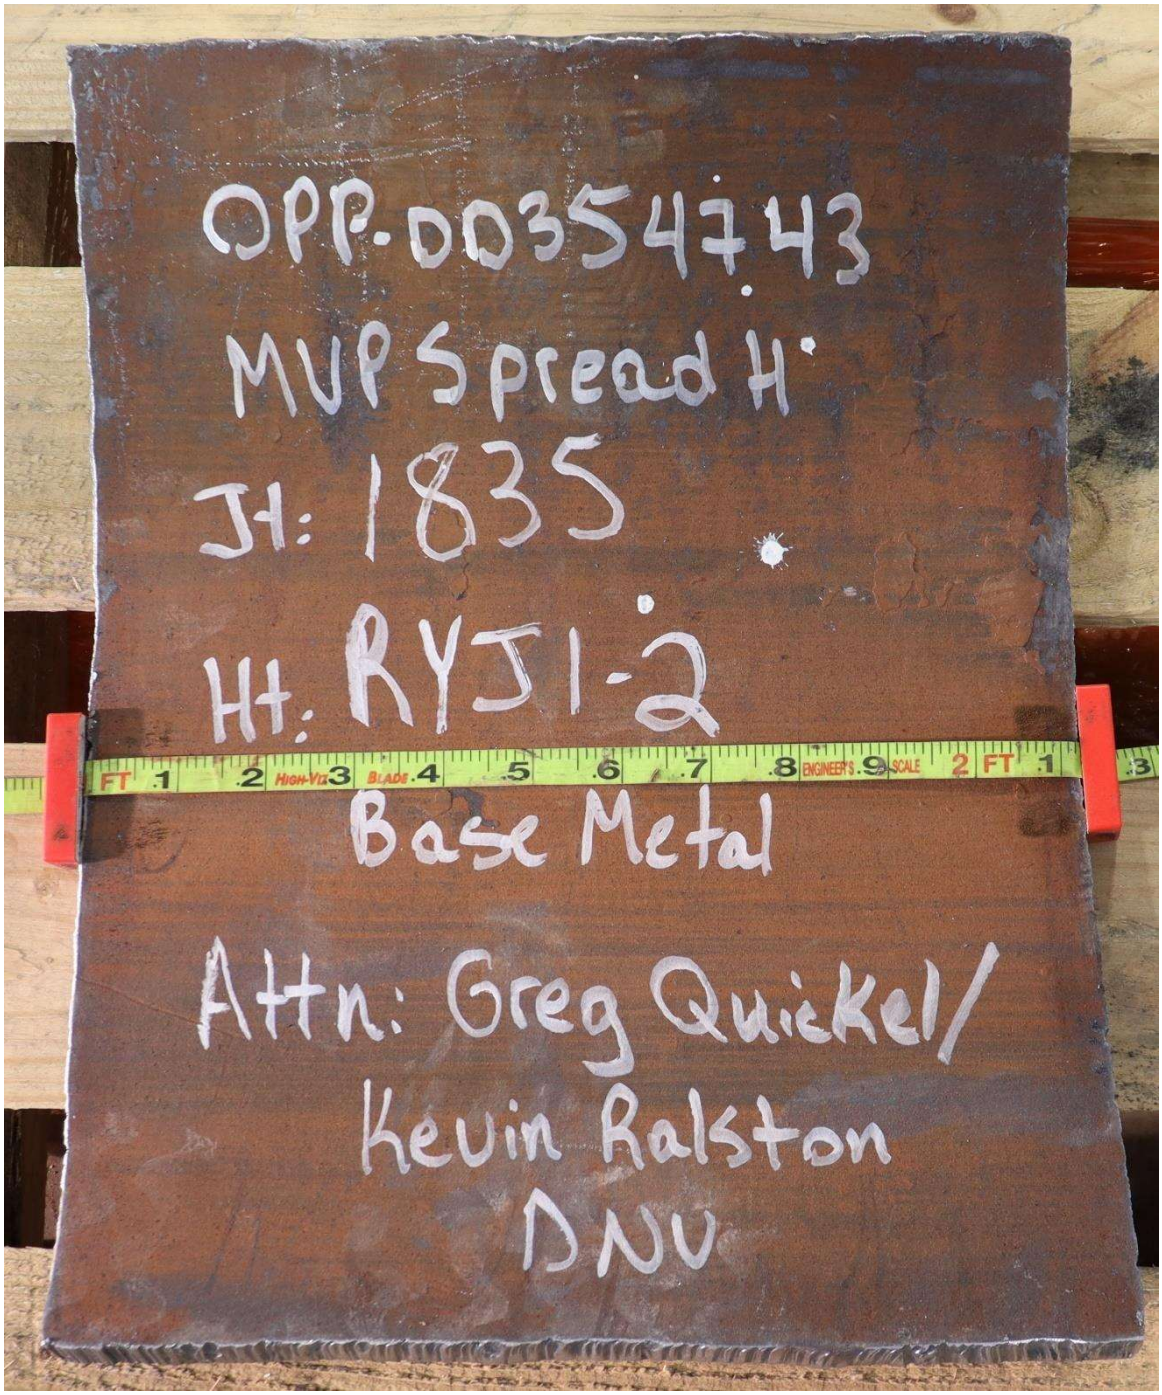
Figure 2. Photograph of the pipe section at DNV, following removal of the protective coverings. The tape measure indicates the distance, in feet, from the U/S end of the pipe section. The portion that was removed from the pipeline (*pipe section*) consists of an elbow fitting and two PUP sections. The pipe section ruptured along the seam weld of the elbow fitting and terminated in the PUP sections. The rupture opening was located between 1.55 and 11.22 feet (116 inches long) from the upstream (U/S) end of the pipe section, with a maximum opening of 10.9 inches at a distance of 7.42 feet from the U/S end of the pipe section or 4.97 feet from the U/S girth weld (GW). Measured near the fracture surface, close to the extrados, the pipe section was approximately 12.6 feet long, the U/S PUP was 2.45 feet long, and the elbow fitting was 7.65 feet long. The seam weld that failed on the elbow fitting was at the 9:06 orientation. The seam welds on the U/S and downstream (D/S) PUPs were at the 6:00 orientations and appeared to be submerged arc welds (SAWs). There was no evidence of external or internal corrosion. The external coating was adhered except for some portions adjacent to the fracture surfaces that disbonded due to the rupture. Portions of the pipe in the white and grey boxes were removed for further fractographic and metallographic analyses.

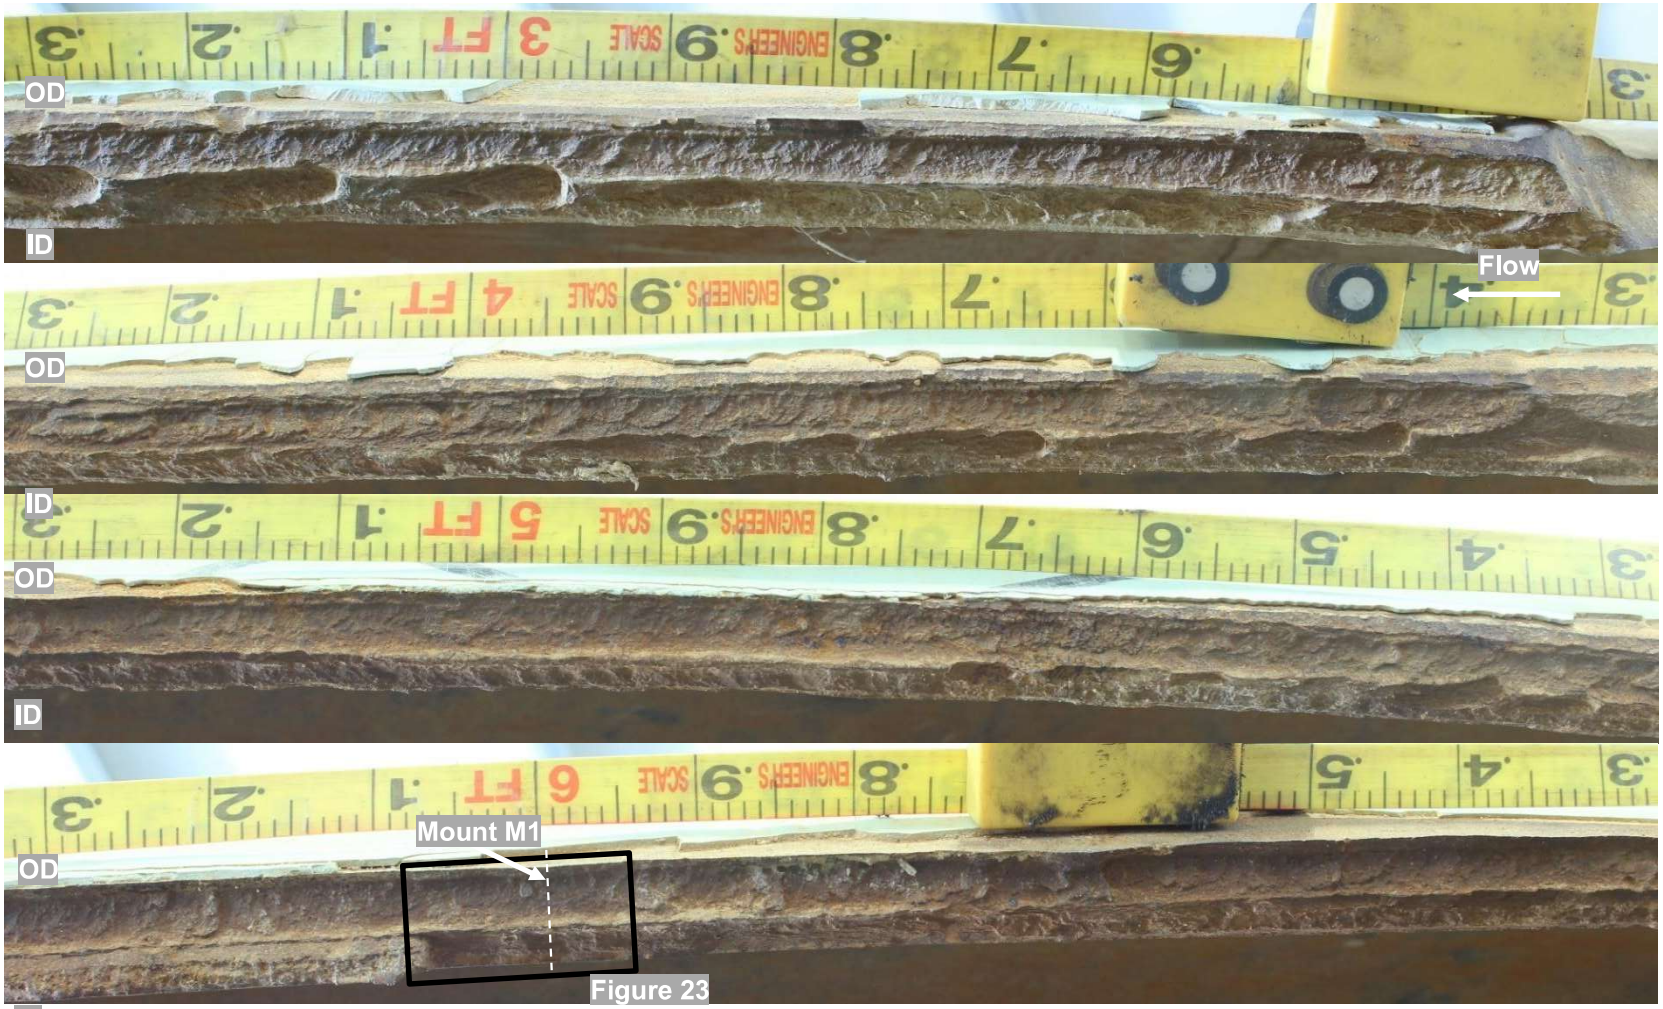
Figure 5. Photographs (4) of the fracture surface counter clockwise (CCW) of the rupture opening from 2.3 to 6.3 feet from the U/S end of the pipe section; area indicated in Figure 2. The tape measure indicates the distance from the U/S end of the pipe section. Chevrons are located on the top photograph indicating that the origin was D/S of that location (3.1 feet D/S from the U/S end of the pipe section). No obvious pre-existing flaws were observed on the fracture surface.

Figure 6. Photographs of the fracture surface CCW of the rupture opening from 6.3 to 10.1 feet from the U/S end of the pipe section; area indicated in Figure 2. The tape measure indicates the distance from the U/S end of the pipe section. Chevrons are located in the bottom two photographs indicating that the origin was U/S of 8.9 feet from the U/S end of the pipe section, indicating the origin is between 3.1 and 8.9 feet from the U/S end of the pipe section, near the middle of the elbow fitting. No obvious pre-existing flaws were observed on the fracture surface. Overall, the fracture surfaces had a similar profile for the entire length where midwall was further away from the camera compared to the OD and ID surfaces. Additionally, the fracture surfaces are slightly rough to macroscopically smooth, except for a few places near the ends of the fracture surfaces.

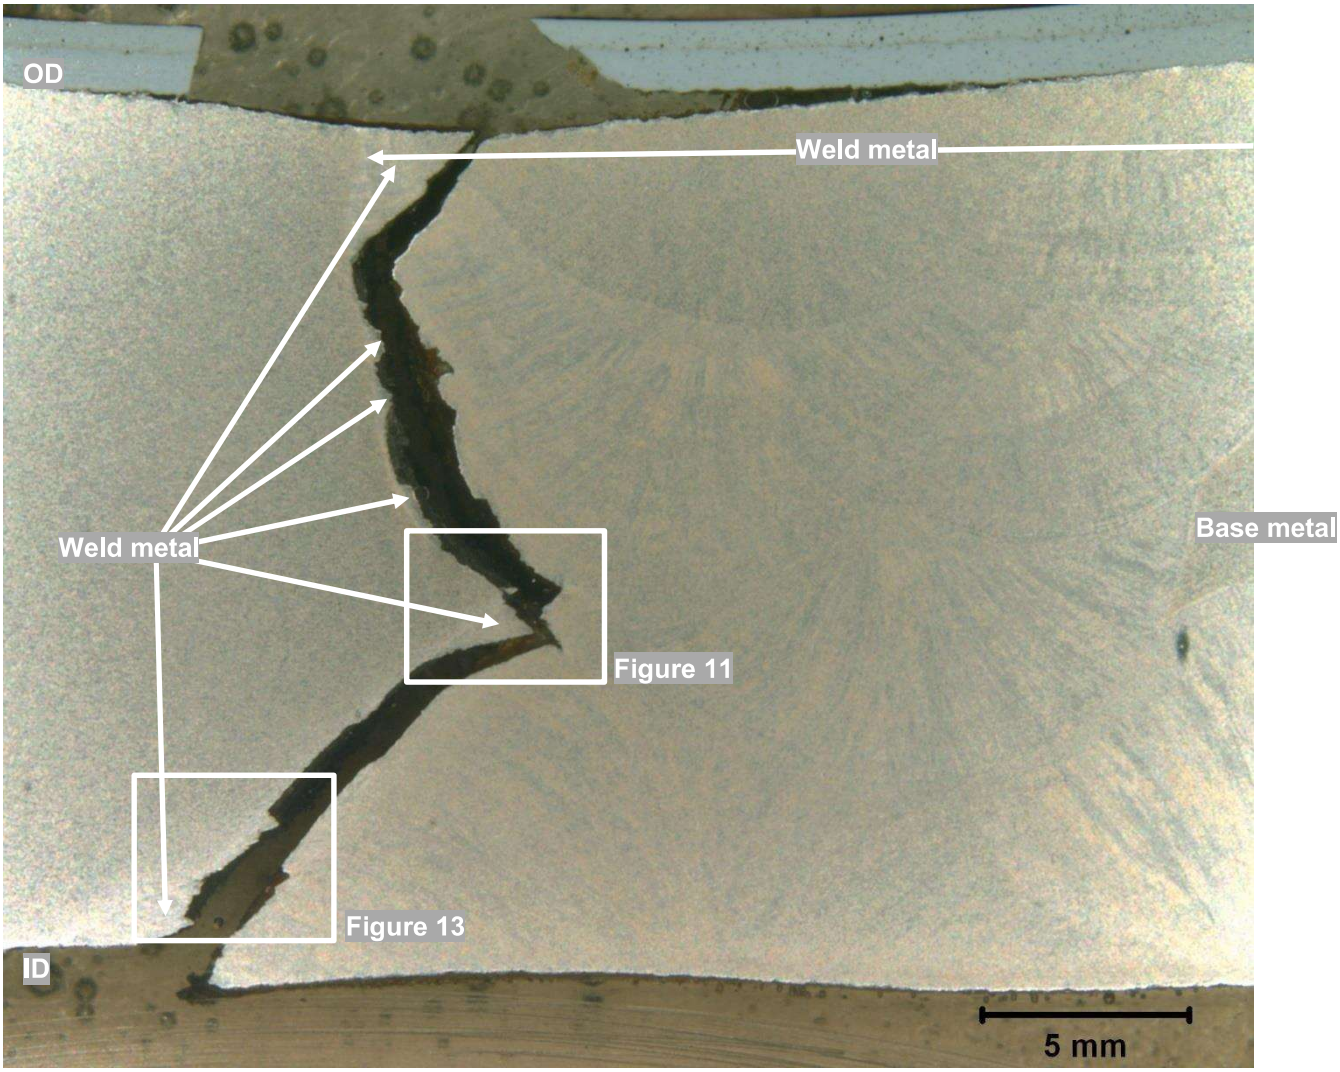
Figure 9. Photograph of the transverse metallographic section (Mount M1) that was removed across the rupture opening, approximately 5.99 feet from the U/S end of the pipe section, near the middle of the elbow fitting. The scale is in inches. See Figure 7 for the mount location. The middle of the fitting was 6.27 feet from the U/S end of the pipe section, near this location. The fracture path appears to be located at or near the fusion line between the weld metal and base metal. The wall thickness at the far left of the cross-section, at the rupture opening, and far right of the cross-section are approximately 0.965 inches, 0.790 inches, and 0.904 inches, respectively. The significant wall reduction/necking is evident in the cross-section and maximum at the rupture opening, consistent with a ductile overload failure. The weld metal on the ID surface is approximately 1.5 inches wide (in the circumferential direction). This cross-section (and adjacent SEM sample) was removed at this location since it appeared to be the thinnest region of the fracture surfaces, due to the necking.

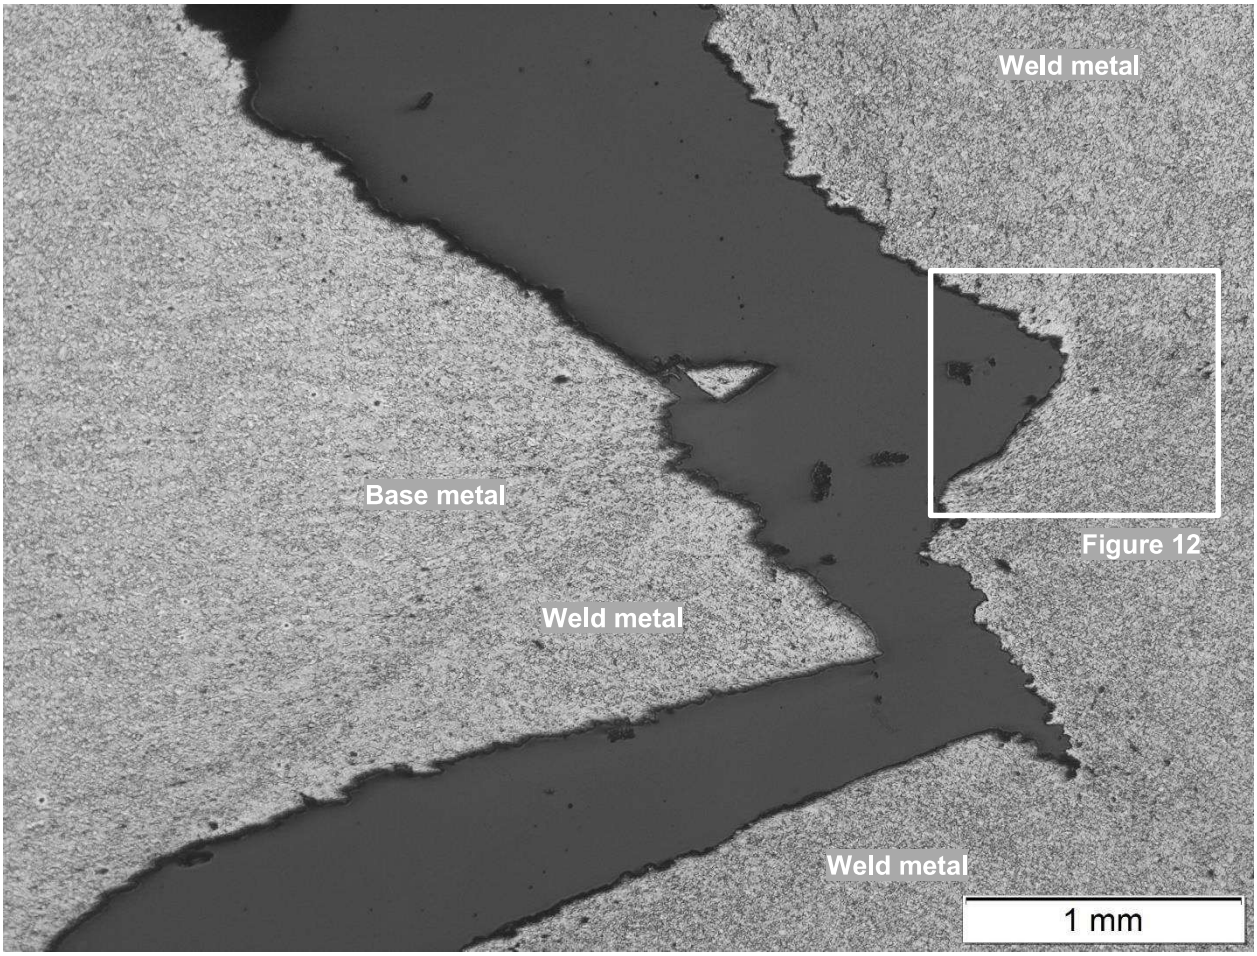
Figure 10. Light photomicrograph of transverse Mount M1 showing the fractures surfaces in cross-section (2% Nital Etchant); area indicated in Figure 9. There appears to be 5 (or 6) weld passes made from the OD surface and 2 from the ID surface with the ID passes being deposited first. The figure shows that the crack path is through the weld metal at the OD surface, ID surface, and midwall, and located at or near the fusion boundary elsewhere. Most of the material is base metal left of the fracture path and weld metal right of the fracture path.

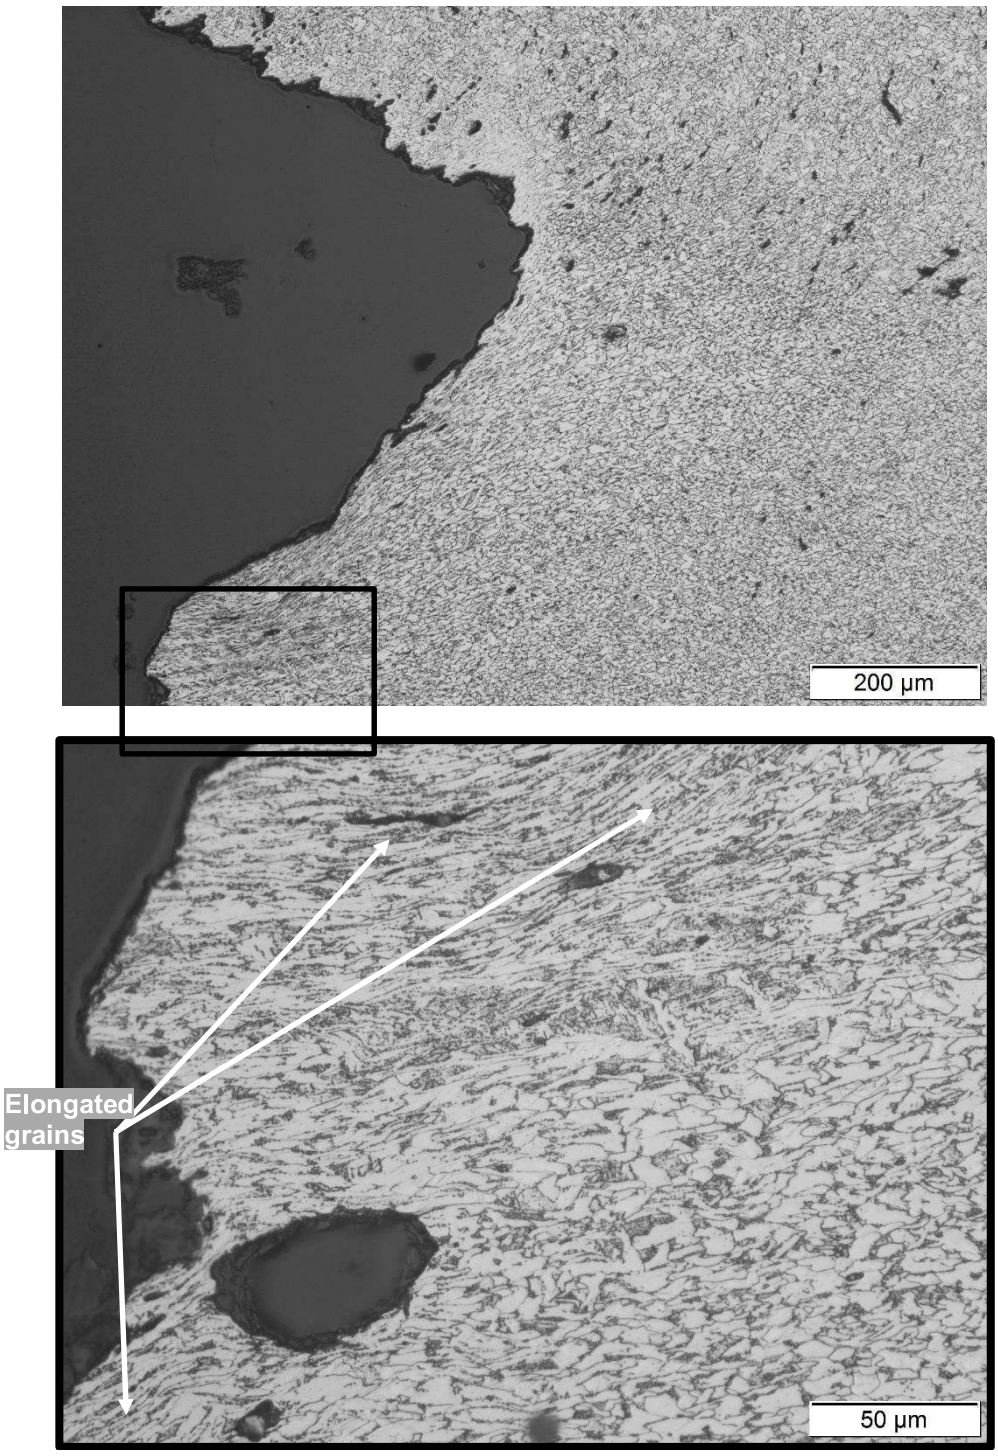
Figure 11. Light photomicrograph of Mount M1 midwall (2% Nital Etchant); area indicated in Figure 10. The figure shows where a portion of the path is through the weld metal and the remainder is at or near the fusion boundary.

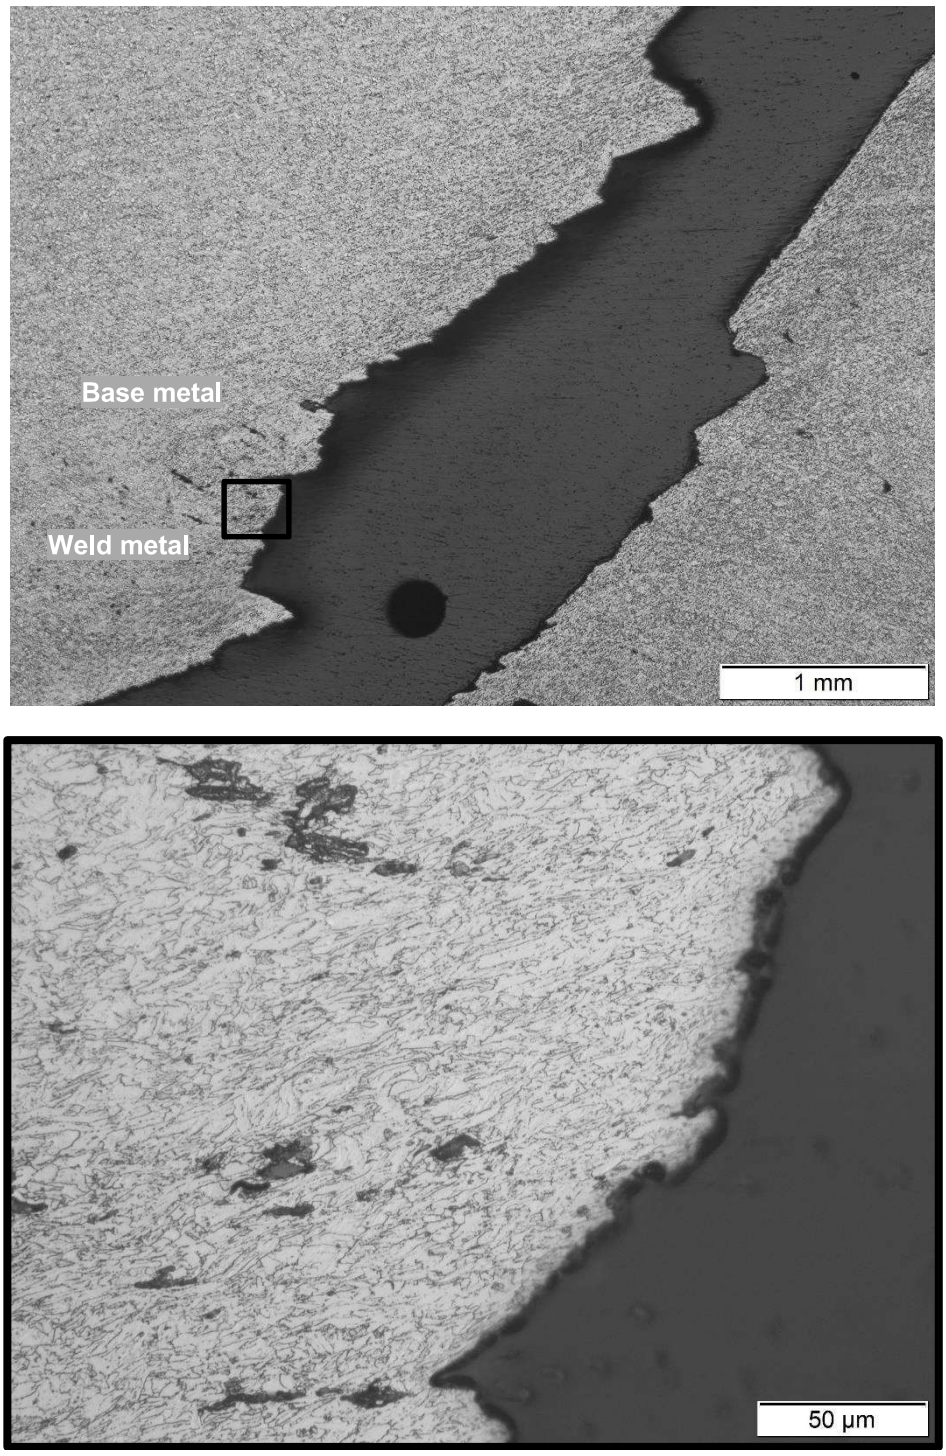
Figure 12. Low and high magnification light photomicrographs of Mount M1 midwall (2% Nital Etchant); area indicated in Figure 11. The figures shows elongated grains adjacent to the fracture surface, which is consistent with ductile overload.

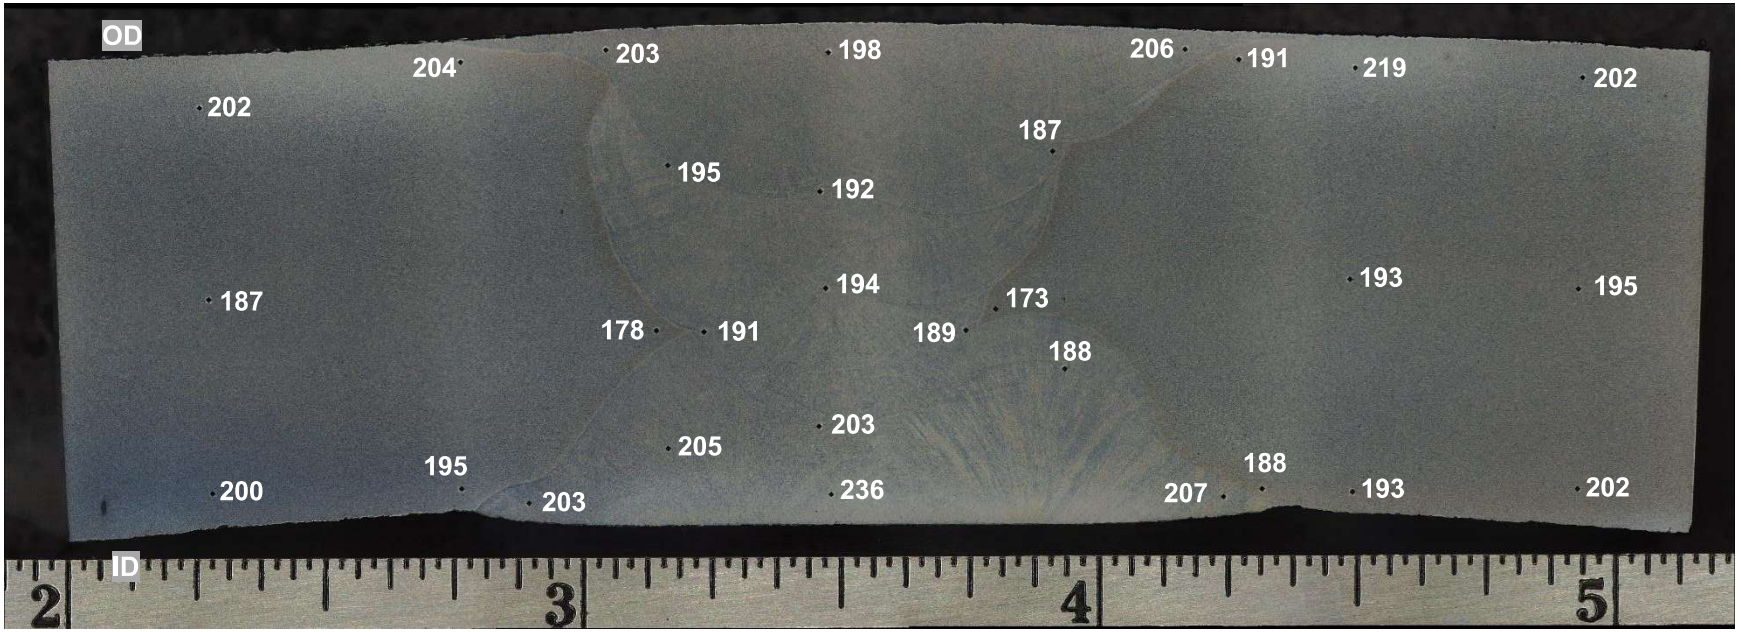
Contributing factors to the lower tensile strength at or near the fusion boundary was softening of the base metal mid-thickness, adjacent to the intersection of the OD and ID weld passes, and

Figure 21. Light photomicrograph of Mount M2 from the failed elbow fitting following hardness testing (Vickers 10 kg load) showing the indents and corresponding hardness values (2% Nital Etchant). The hardness values are between 180 HV and 230 HV, with an average value of 202HV. The mid-thickness of the sample is slightly softer than the outer edges. The softest portion of the base metal is mid thickness near the weld metal (186 HV), near the intersection of OD and ID weld passes. The second lowest base metal value of 192 HV is adjacent to the fracture surface, mid-thickness, adjacent to the second softest weld metal value of 187 HV. The value of 192 HV may be higher than what was present prior to the hydrotest as grain elongation from the overload would locally increase the hardness. Overall, there appears to be a slight softening of the base metal mid-thickness adjacent to the weld metal, where the weld metal is also somewhat softer compared to the outer edges of the weld metal. This mid-thickness softening at and near the weld is what would be expected since those regions of the weld have been tempered by subsequent weld passes.

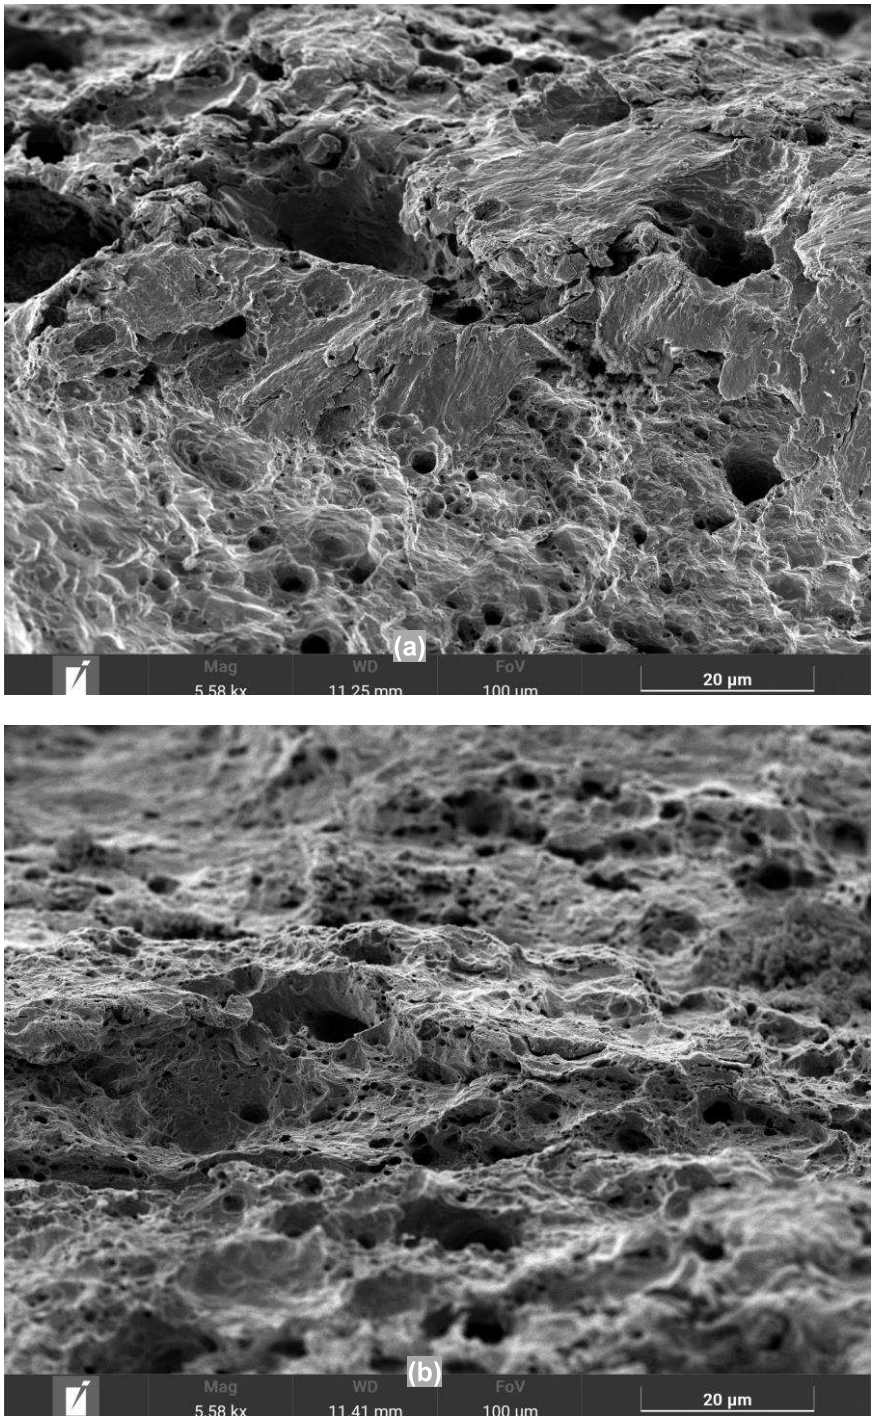
Figure 26. SEM image of Sample S1 midwall showing the fracture surface near midwall; area indicated in Figure 23. The fracture surface at this location also contains dimples, consistent with ductile overload.

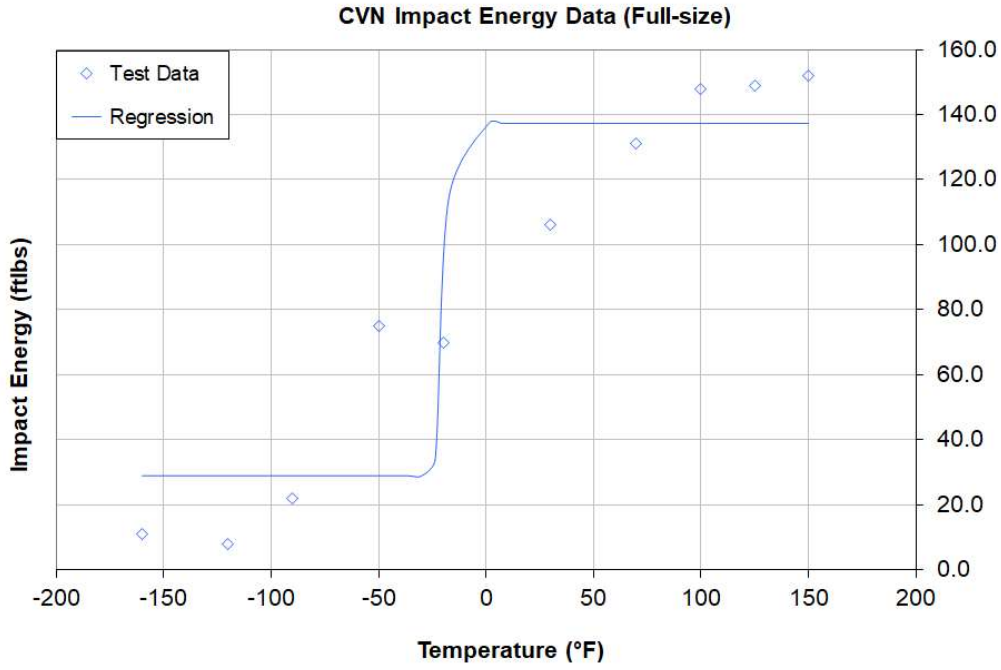
- For the CVN testing of the sister elbow fitting, the upper shelf impact energy value of the HAZ is typical when compared to 2018 vintage line pipe steel, and the 85% fracture appearance transition temperature (FATT) value is higher (poorer) than typical when compared to 2018 vintage line pipe steel.

Figure 32. Percent shear from Charpy V-notch tests as a function of temperature for transverse seam weld (HAZ notch) specimens removed from the sister elbow fitting.
